Port Sunlight Landscape Condition Survey Report

Port Sunlight Village Trust

Prepared by Ryder Landscape Consultants

July 2017

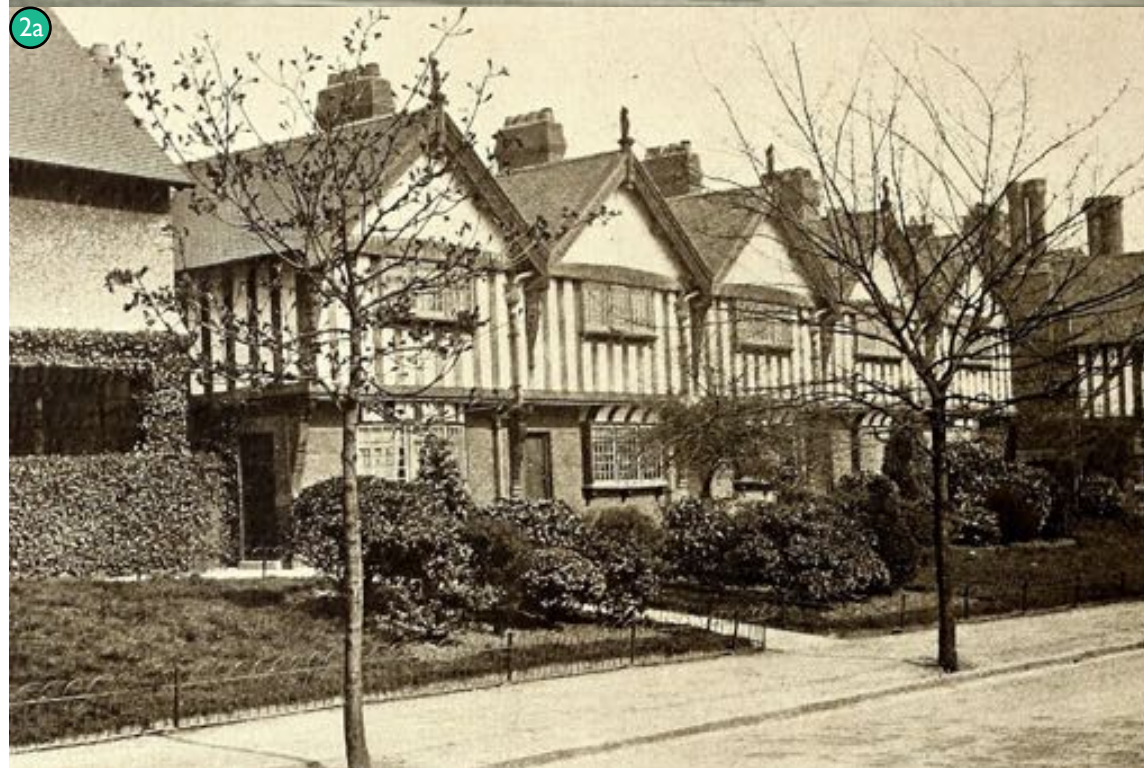
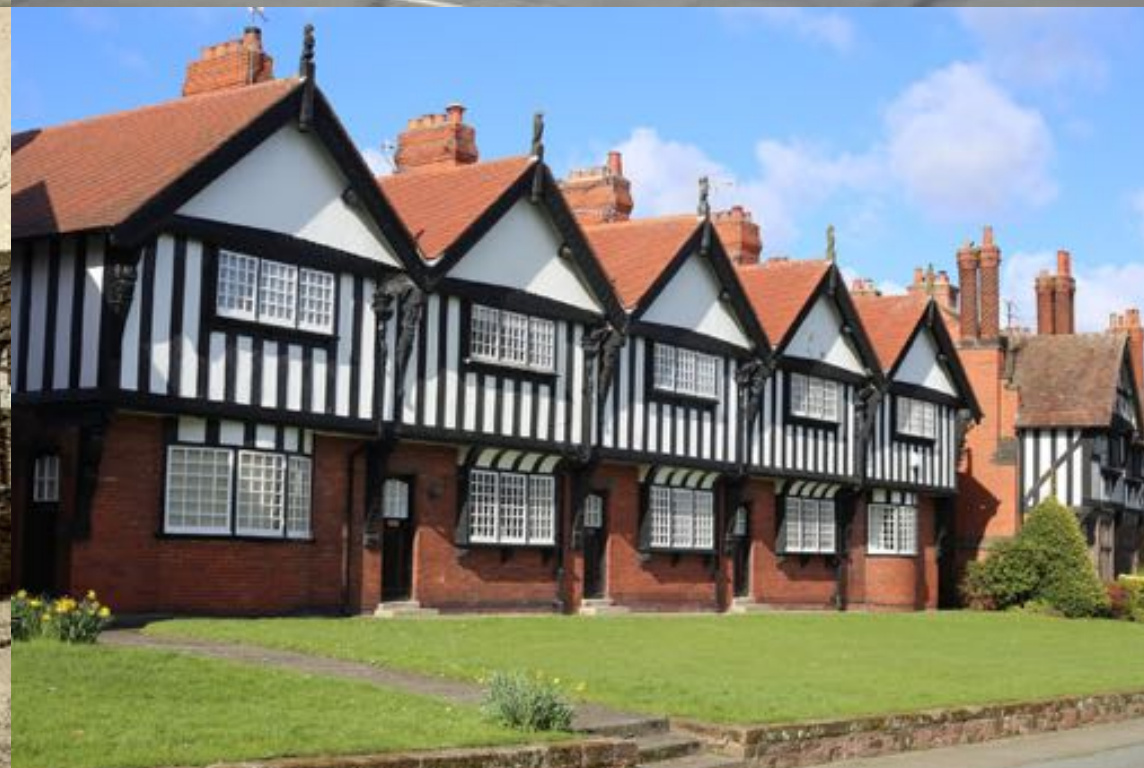
2a

Despite the character of the view being very different through the loss of street trees and railings, the new character works well with the properties overlooking the Dell.

Overall management recommendation would be to maintain the status quo within this area, however a review and rationalisation of street furniture (raised planters, signs, phone boxes etc.) outside The Tudor Rose Tea Rooms would help in terms of legibility and maintain a clear street aesthetic and sense of space at this junction.

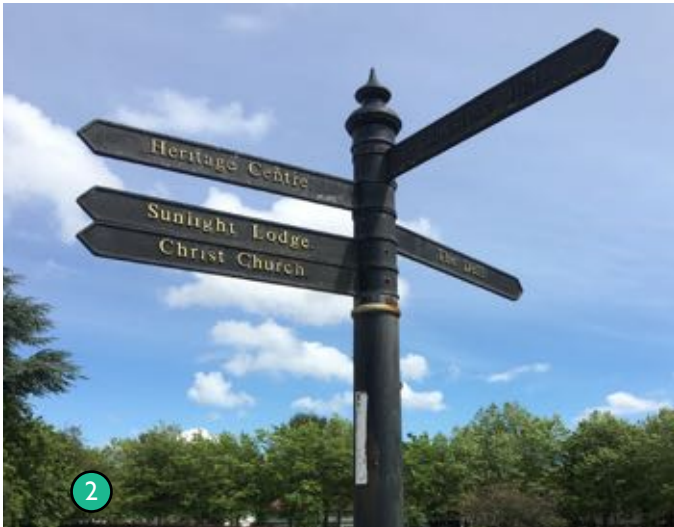
Character Area 3
Finger post, Bolton Road

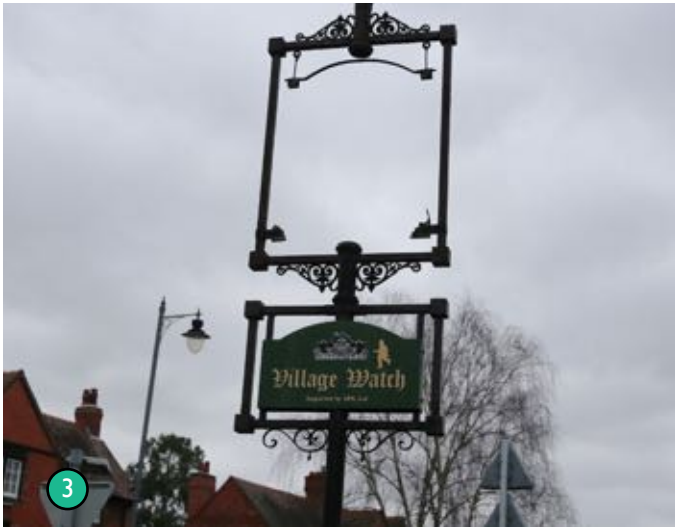
Character Area 3
Incomplete name sign - otherwise in good condition, Green-
dale Road

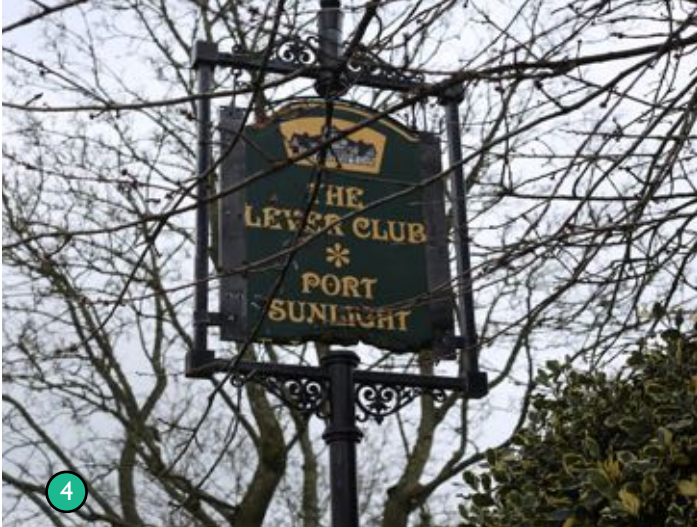
Character Area 3
Damaged Lever Club sign

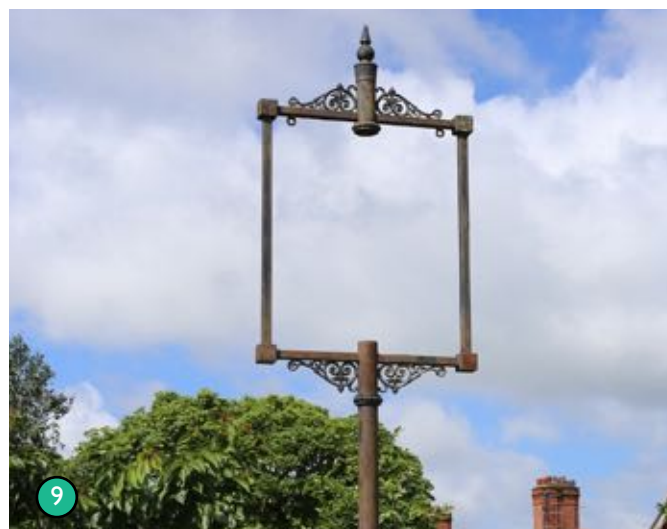
Character Area 8
Incomplete sign in poor condition, New Chester Road

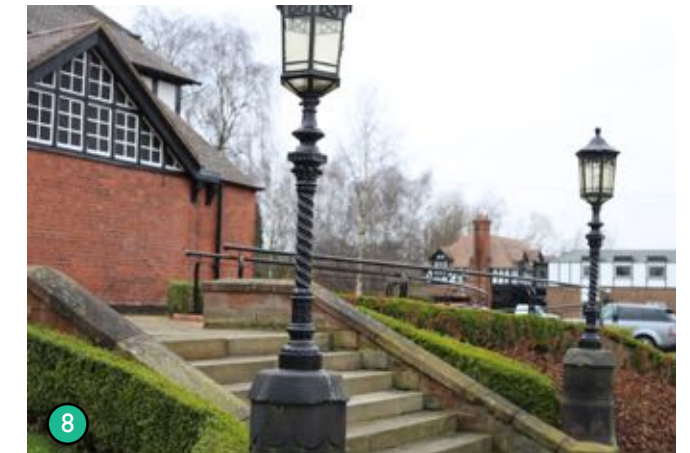
Character Area 3
Steps to properties along Greendale Road - trip/slip hazard

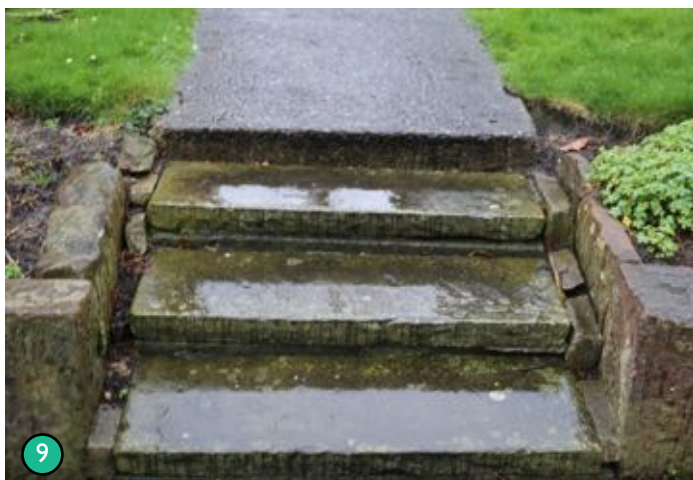
Character Area 3
Steps to Gladstone Theatre - lack of visible edge markings or handrail

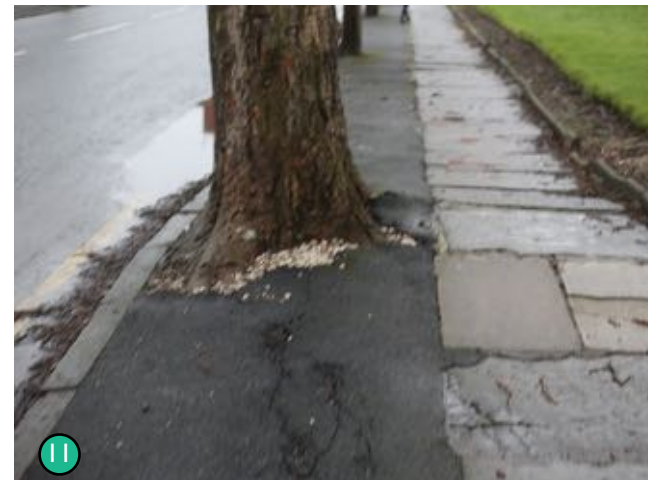
Character Area 5
Paving with root heave and uneven surfaces- trip/slip hazard

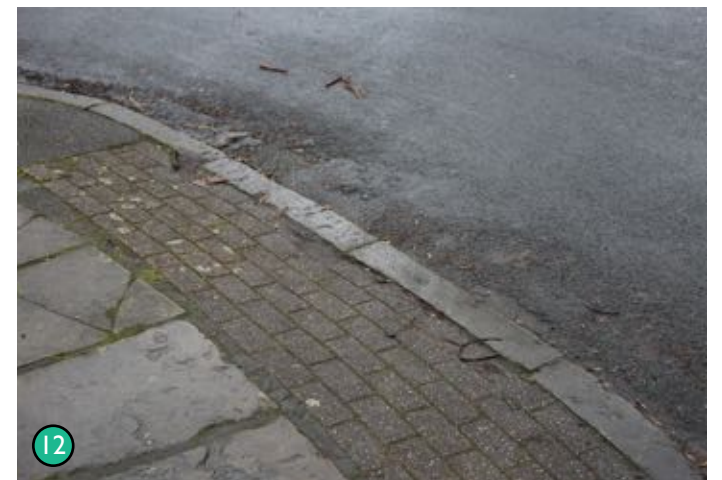
Character Area 6
Paving with root heave and uneven surfaces- trip/slip hazard

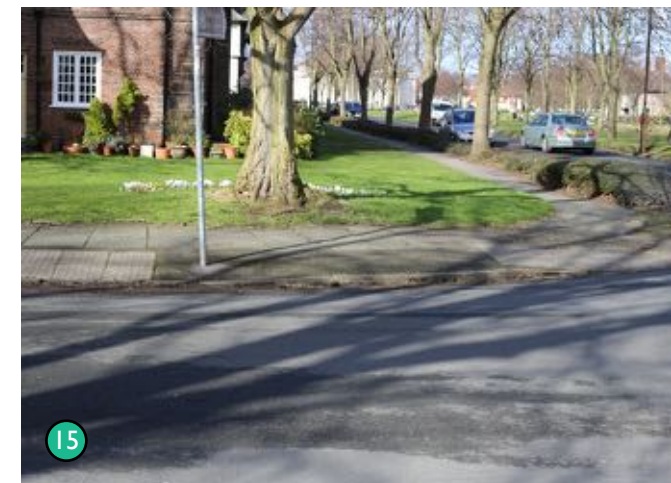
Character Area 8
The Ginnel - lack of hazard warning paving at pedestrian crossing point

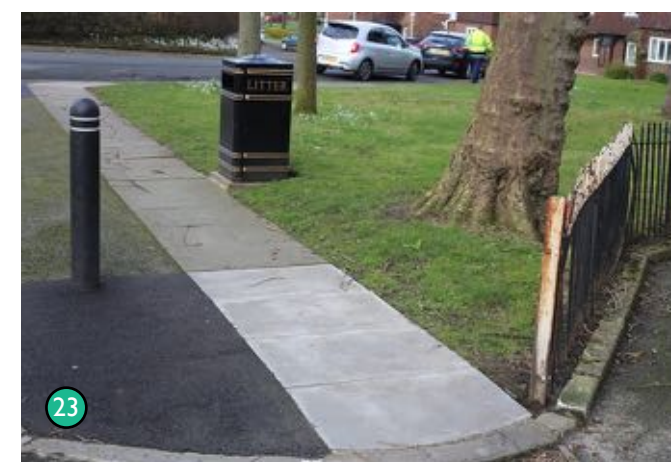
Character Area 12
Trip hazards along Greendale Road

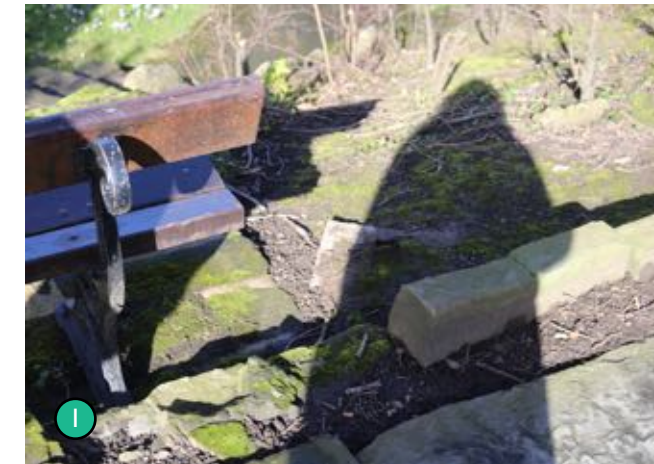
Character Area 2

Damaged paving outside the Dell - trip hazard

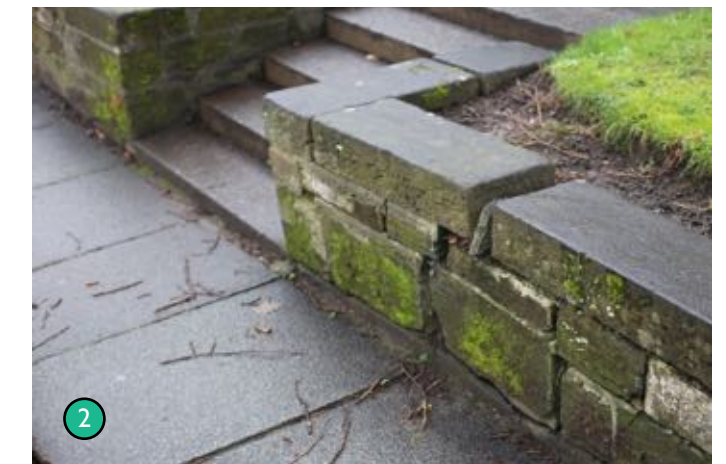
Character Area 7

Damaged retaining wall, Queen Mary's Drive - collapsing blocks

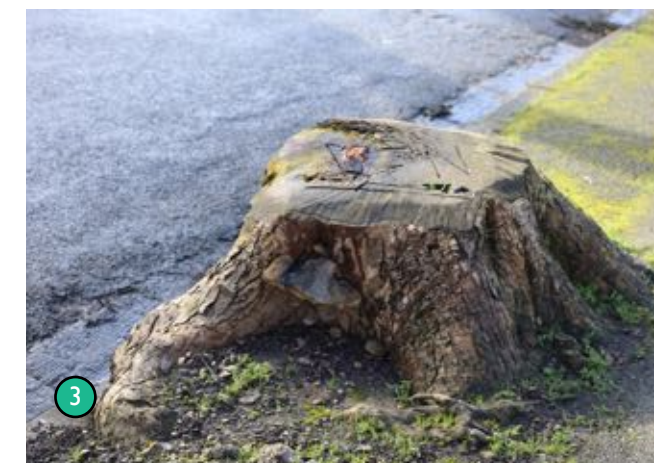
Character Area 8

Tree stump leftover in paving - trip hazard

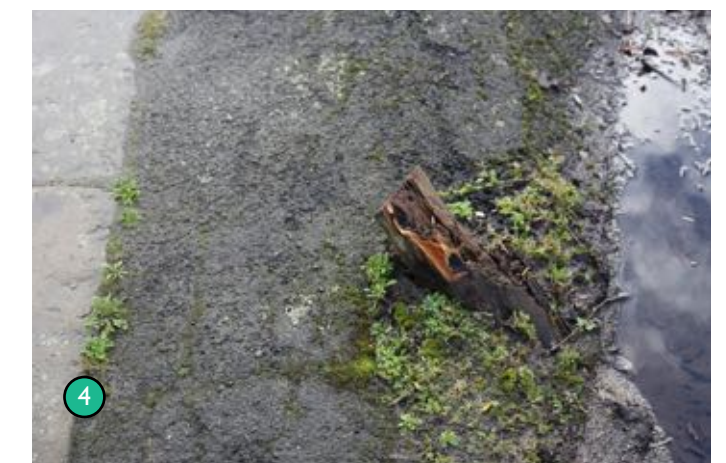
Character Area 8

Tree stump in paving - trip hazard

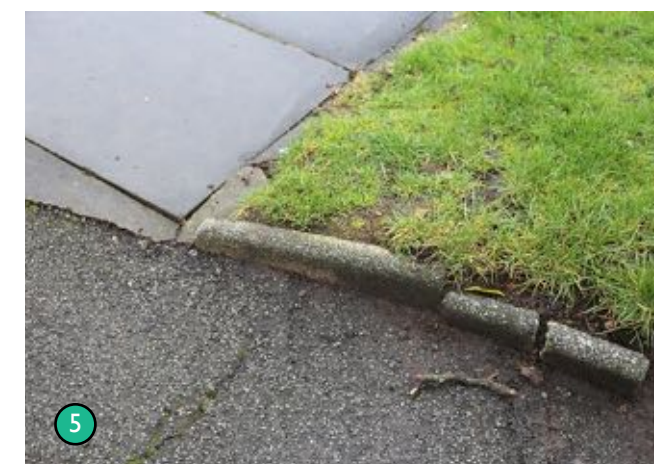
Character Area 7

Damaged kerb edge - trip hazard

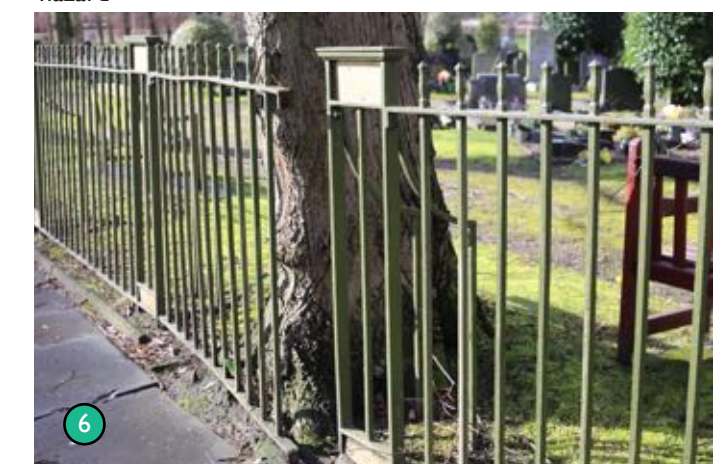
Character Area 10

King Edward's Drive, Church railing damaged by trees - tripping hazard
