Port Sunlight Landscape Condition Survey Report

Port Sunlight Village Trust

Prepared by Ryder Landscape Consultants

July 2017

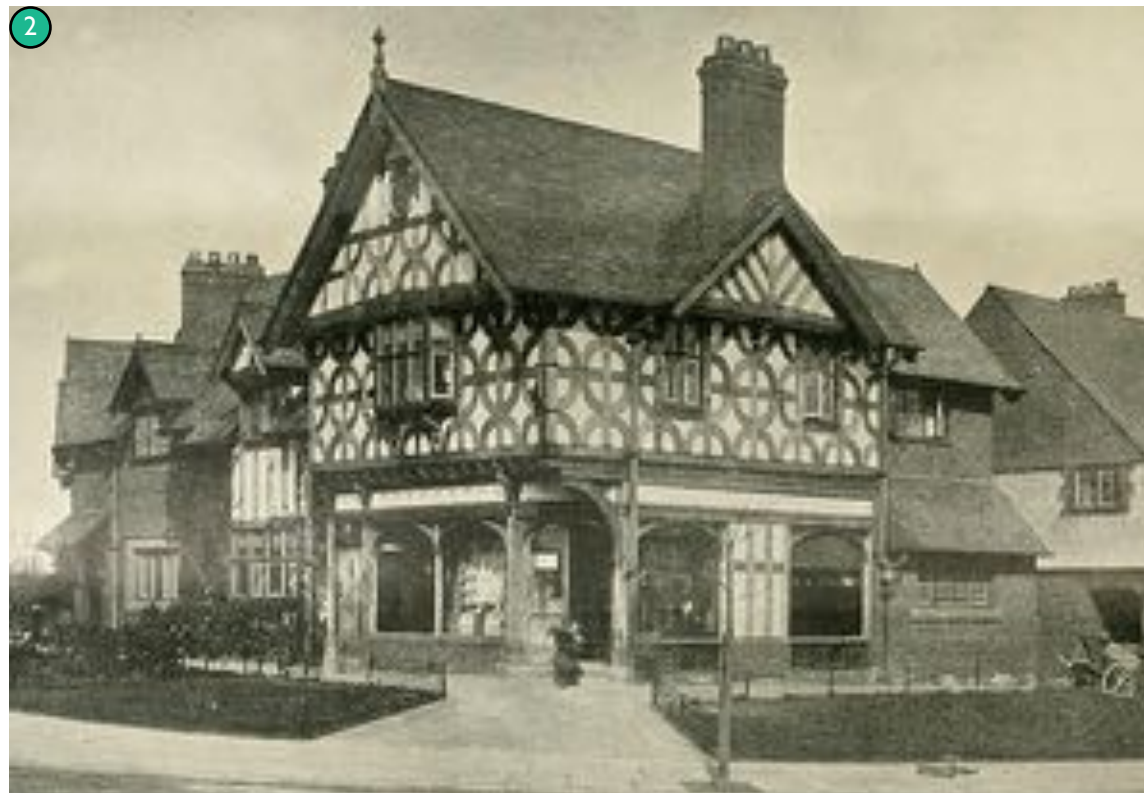
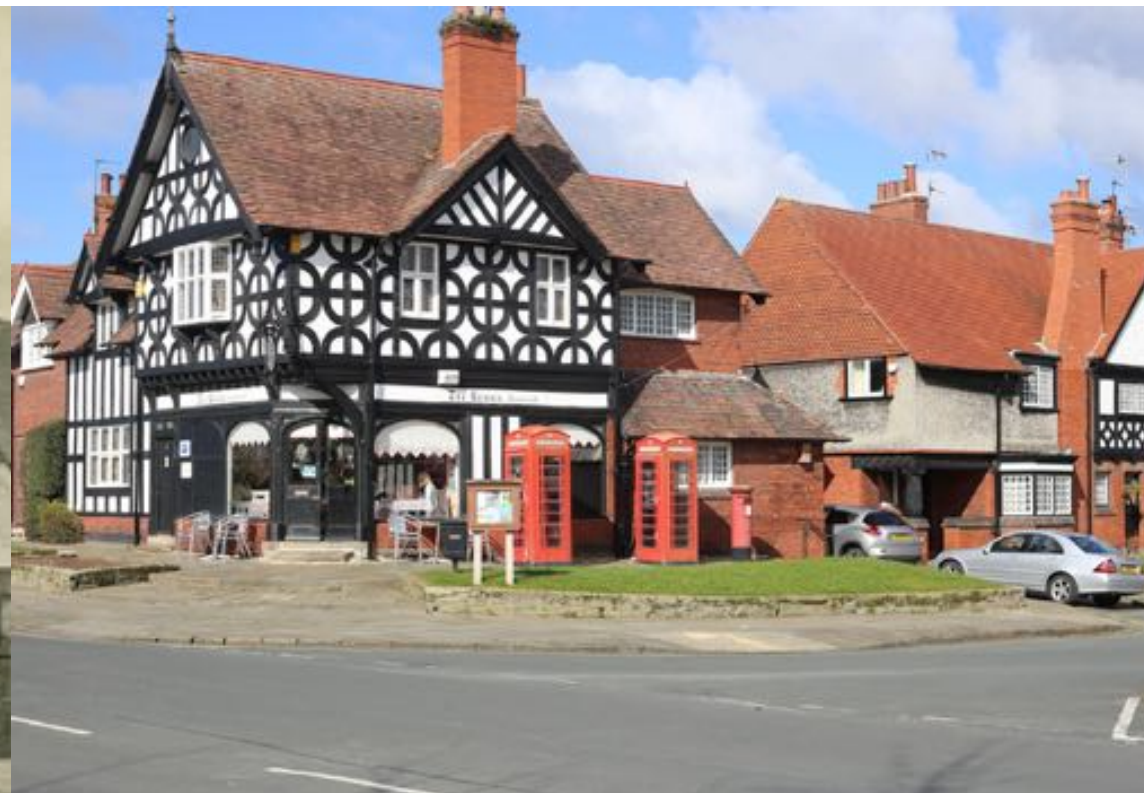
2

An open tree lined street with grass fronts lawns and railings* along Park Road with a shop at the junction with Greendale Road.

Overall management recommendation would be to maintain the status quo within this area, however a review and rationalisation of street furniture (raised planters, signs, phone boxes etc.) outside The Tudor Rose Tea Rooms would help in terms of legibility and maintain a clear street aesthetic and sense of space at this junction.

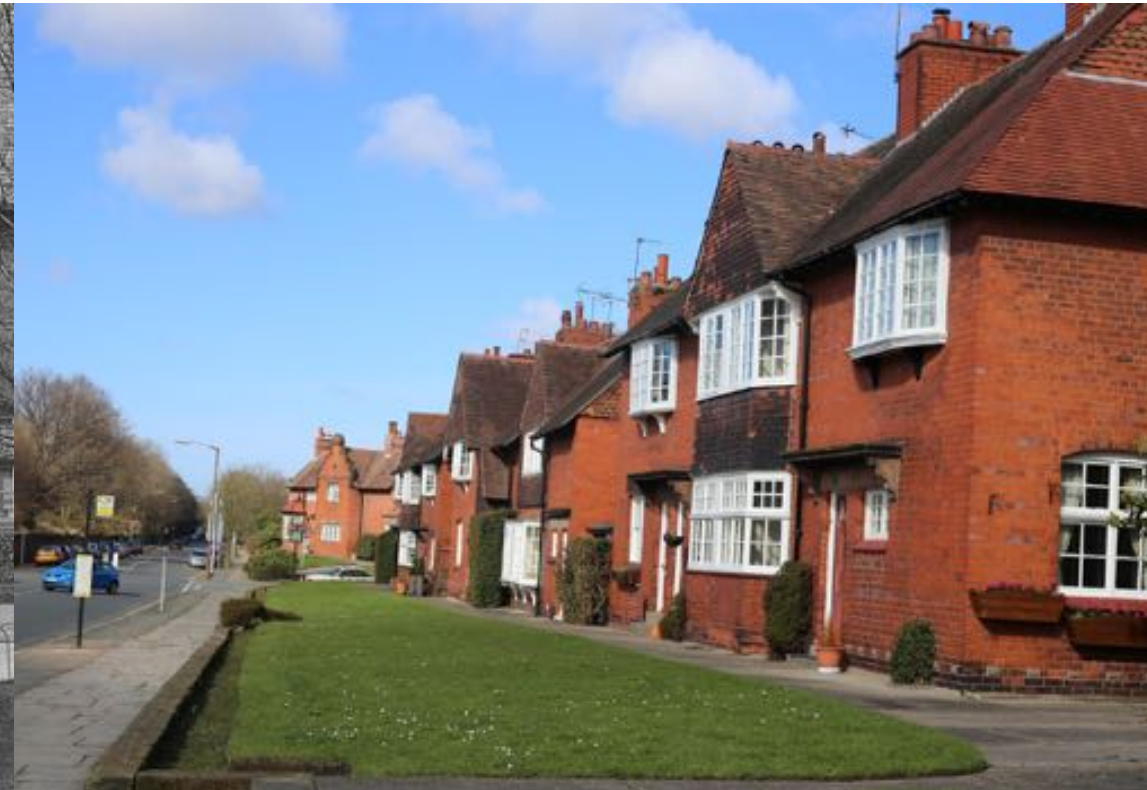
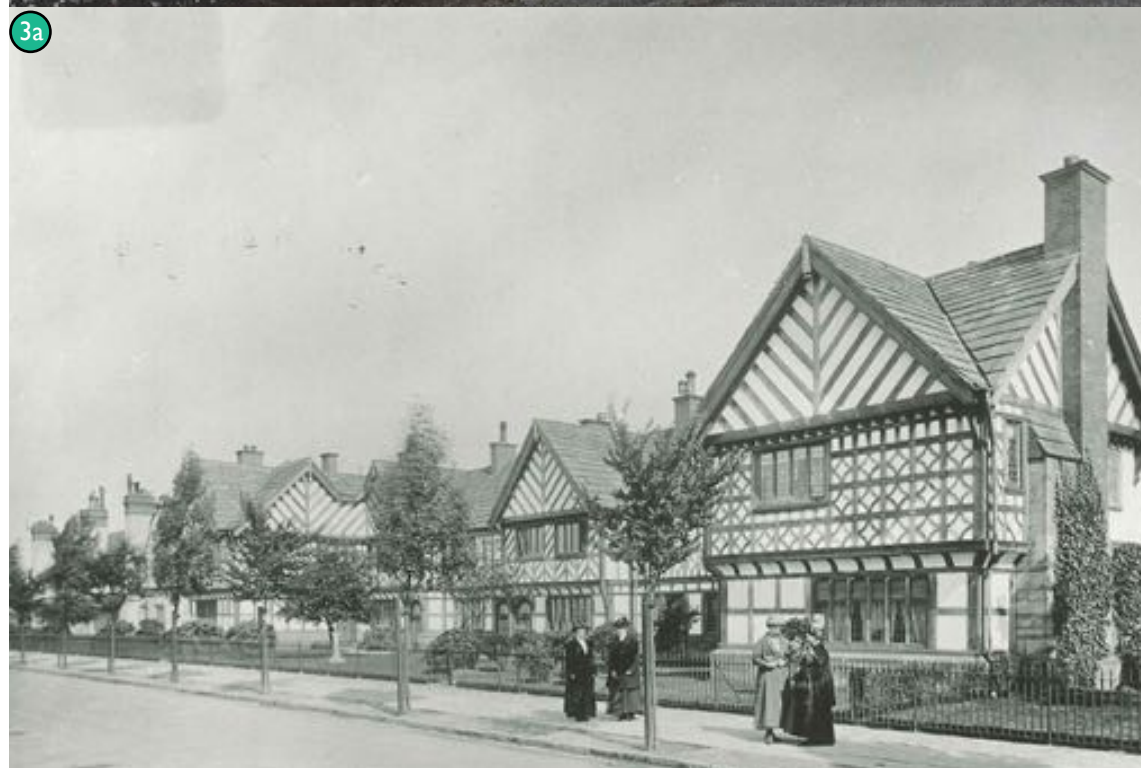
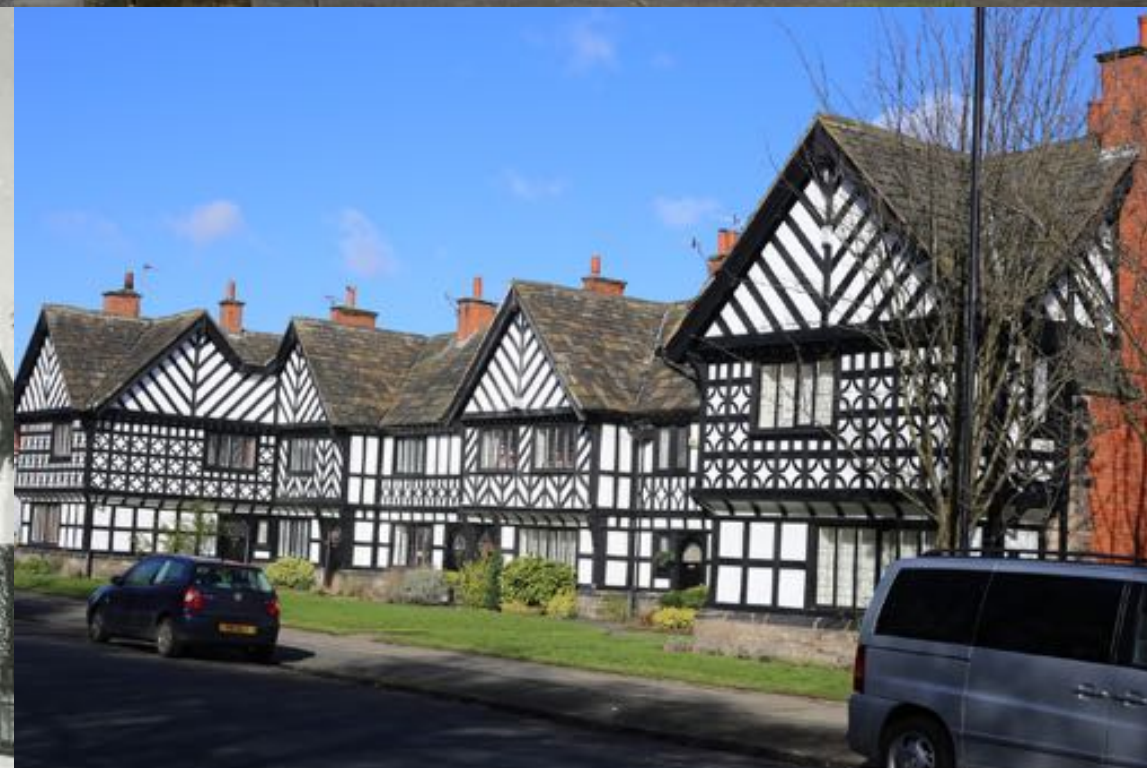
A tree lined street (likely poplars) with low railings, shrubs (laurel) and specimen tree species to property frontages.

Even though the view focus is on the property, it is largely different from the original design or character through the loss of landscape features. Maintenance of this 'new' character along Greendale Road is recommended including infilling of the unfilled gaps. A long term aspiration could be the introduction of specimen tree species to complement the property frontages.

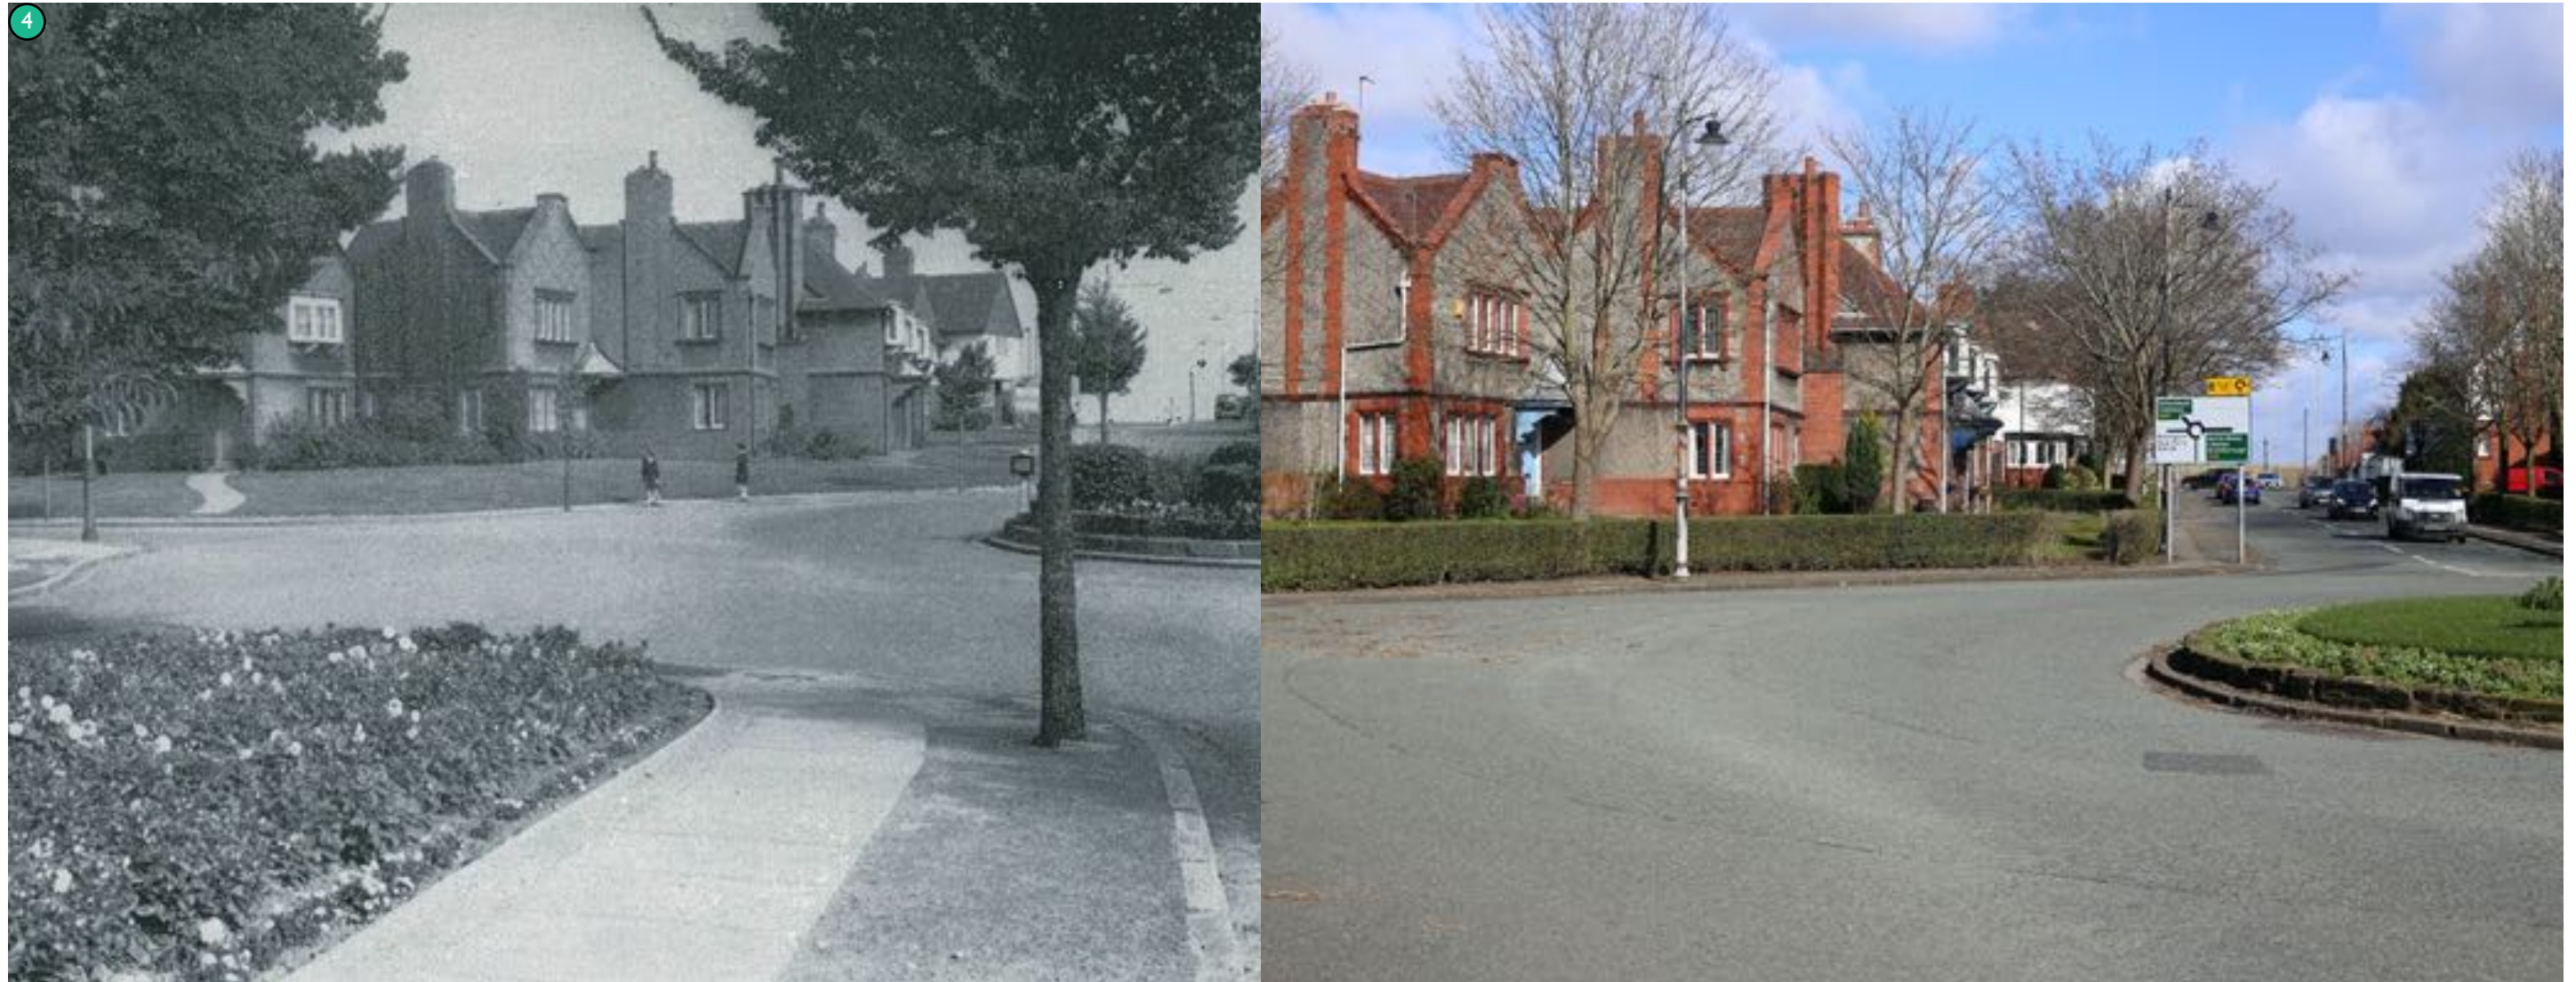
A tree lined street with amenity planting, open property fronts and Bolton Road Roundabout acting as feature.

The view is mainly intact, with some additions over time slightly altering the character of the street including old to contemporary road signs. A wider review of the hierarchy of road signage across the village is recommended. Simple maintenance works to lighting columns and trees in front of properties is required.

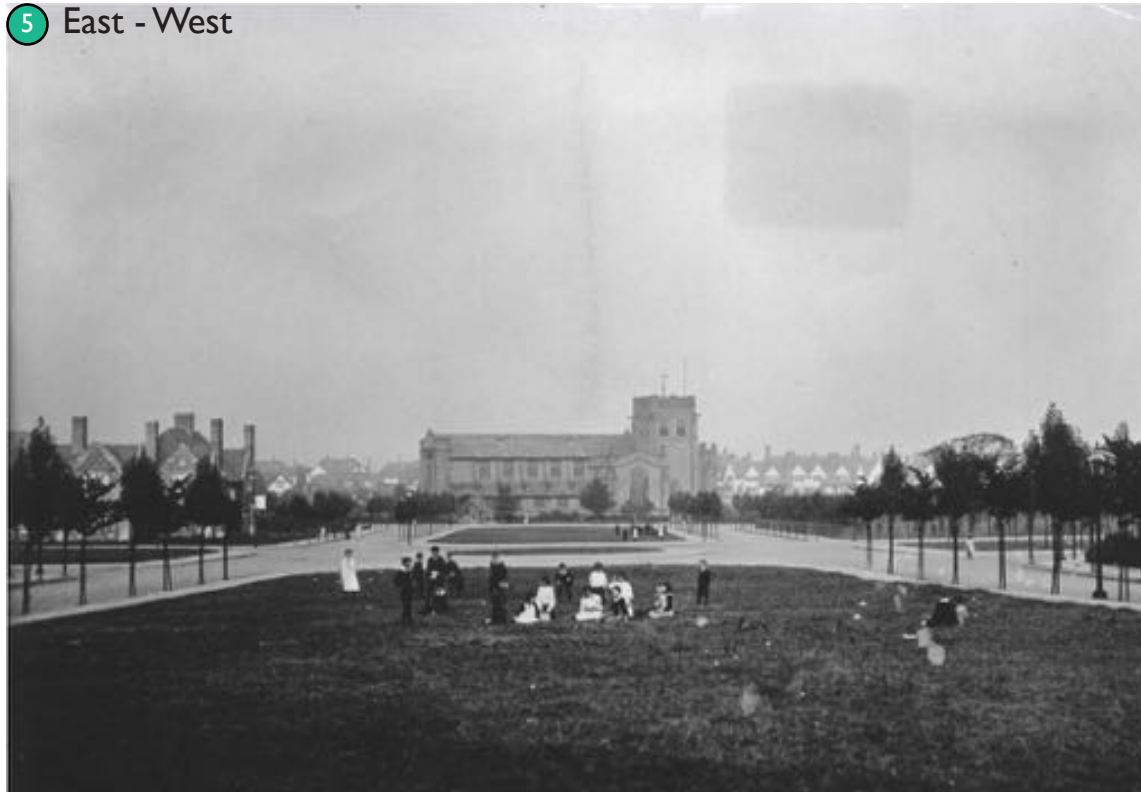
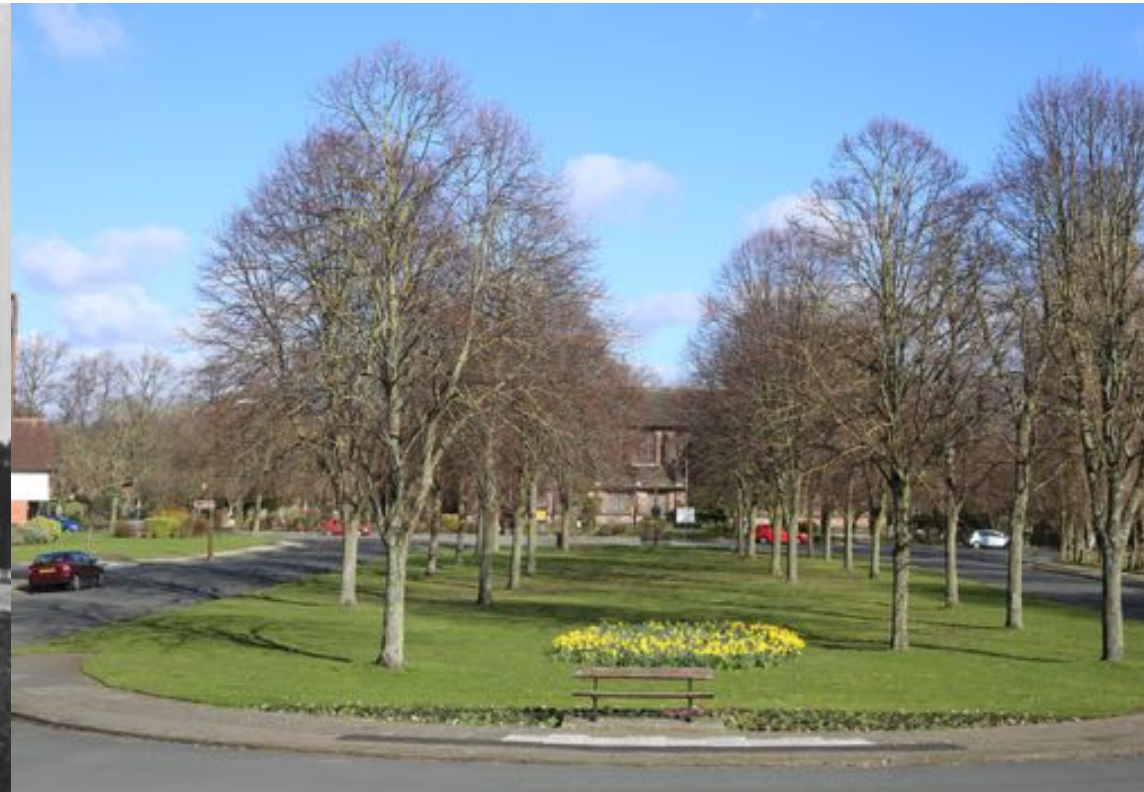
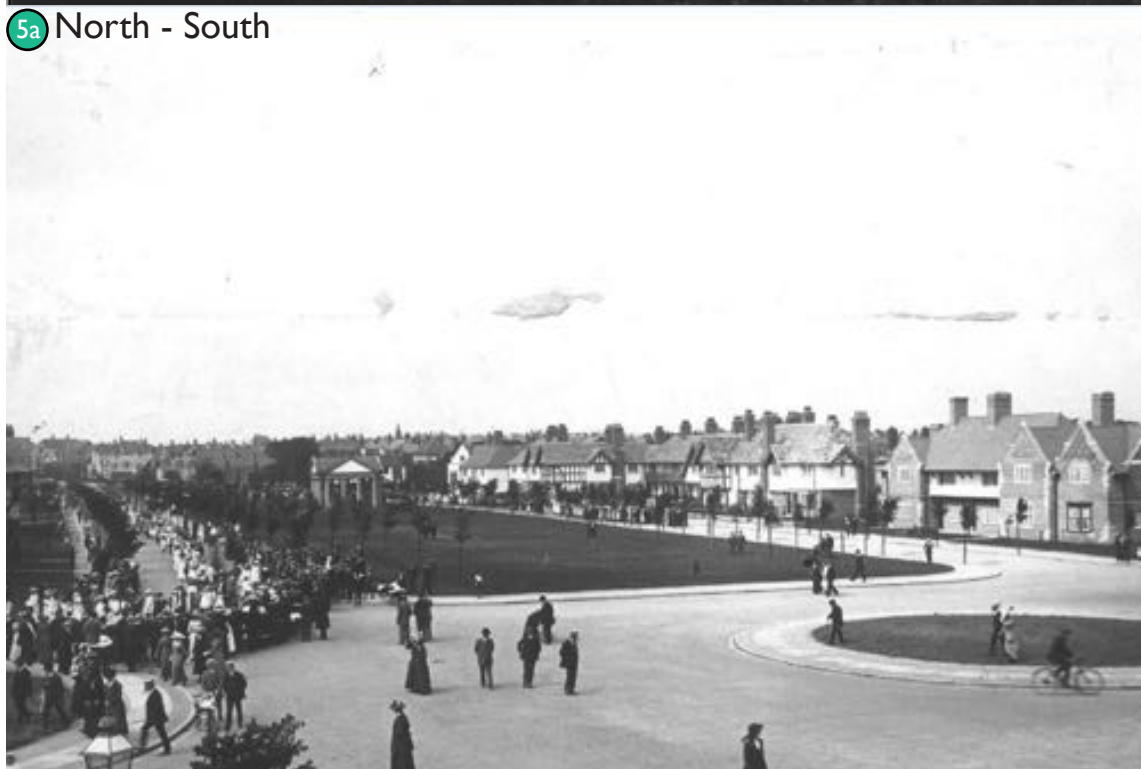
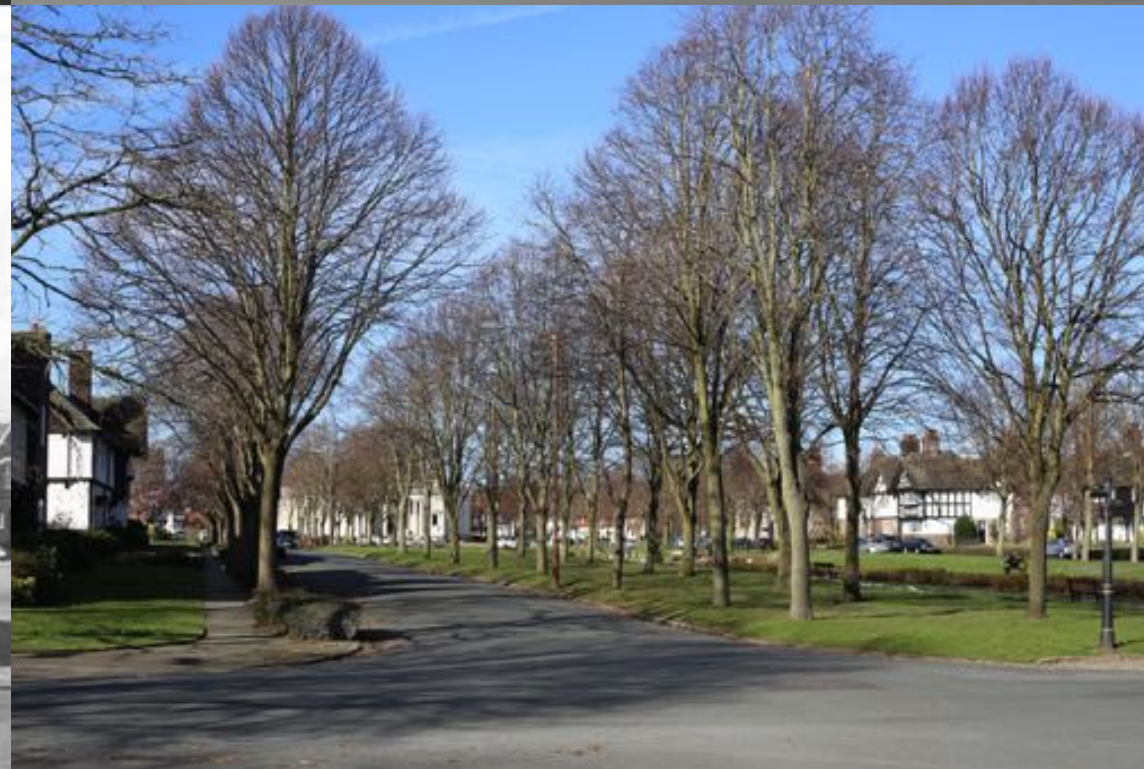
Figure 5: The Diamond and The Causeway

Open vistas either North - South along the Diamond to the future of Lady Lever Art Gallery or East - West to the Christ Church. Tree lined streets around open green spaces.

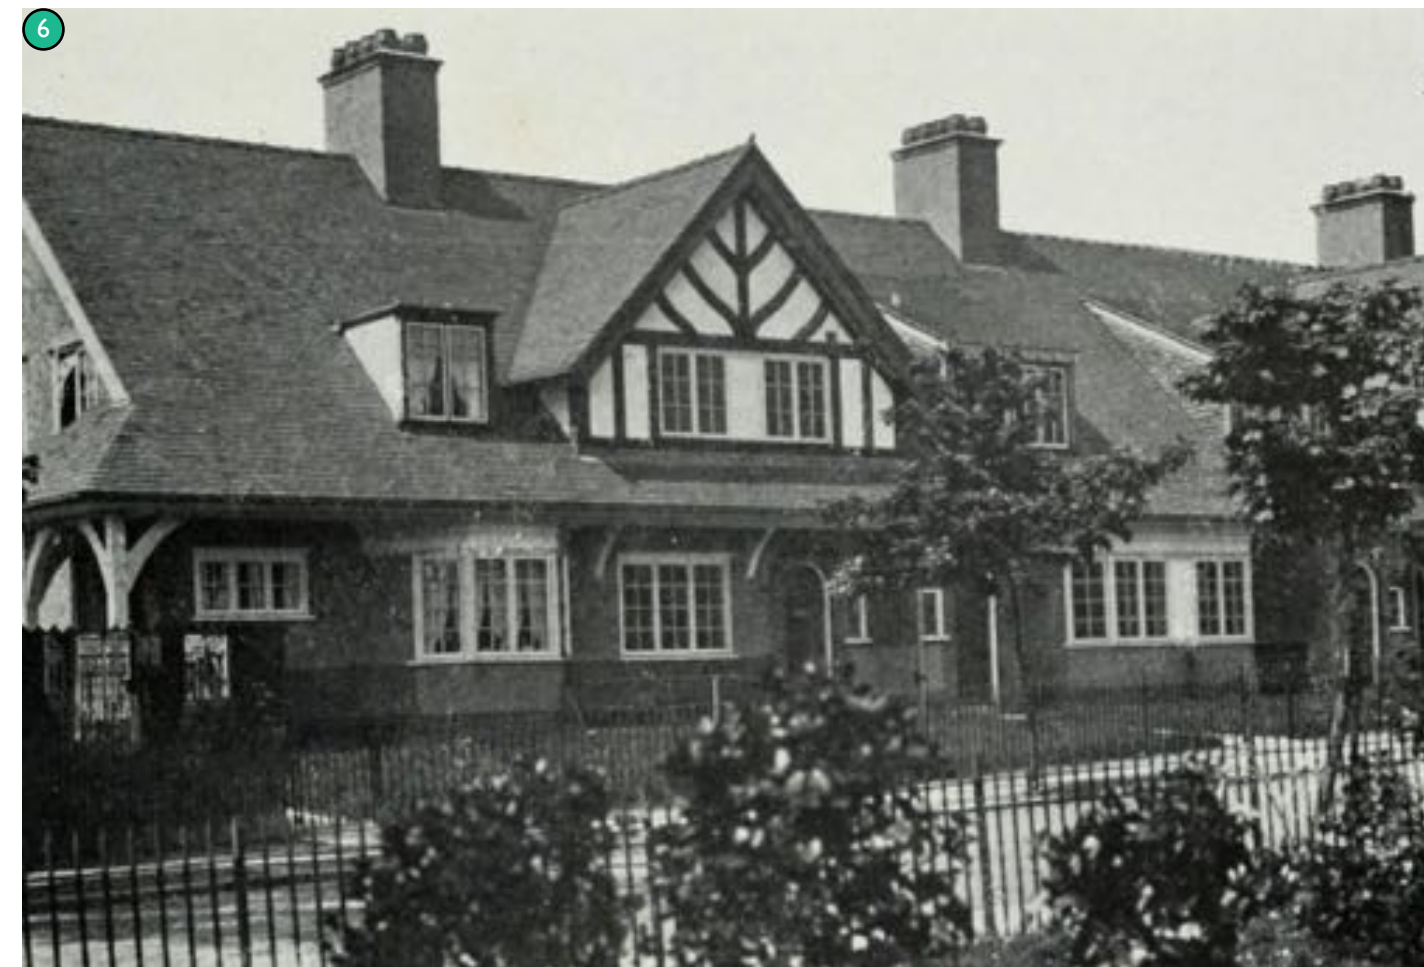
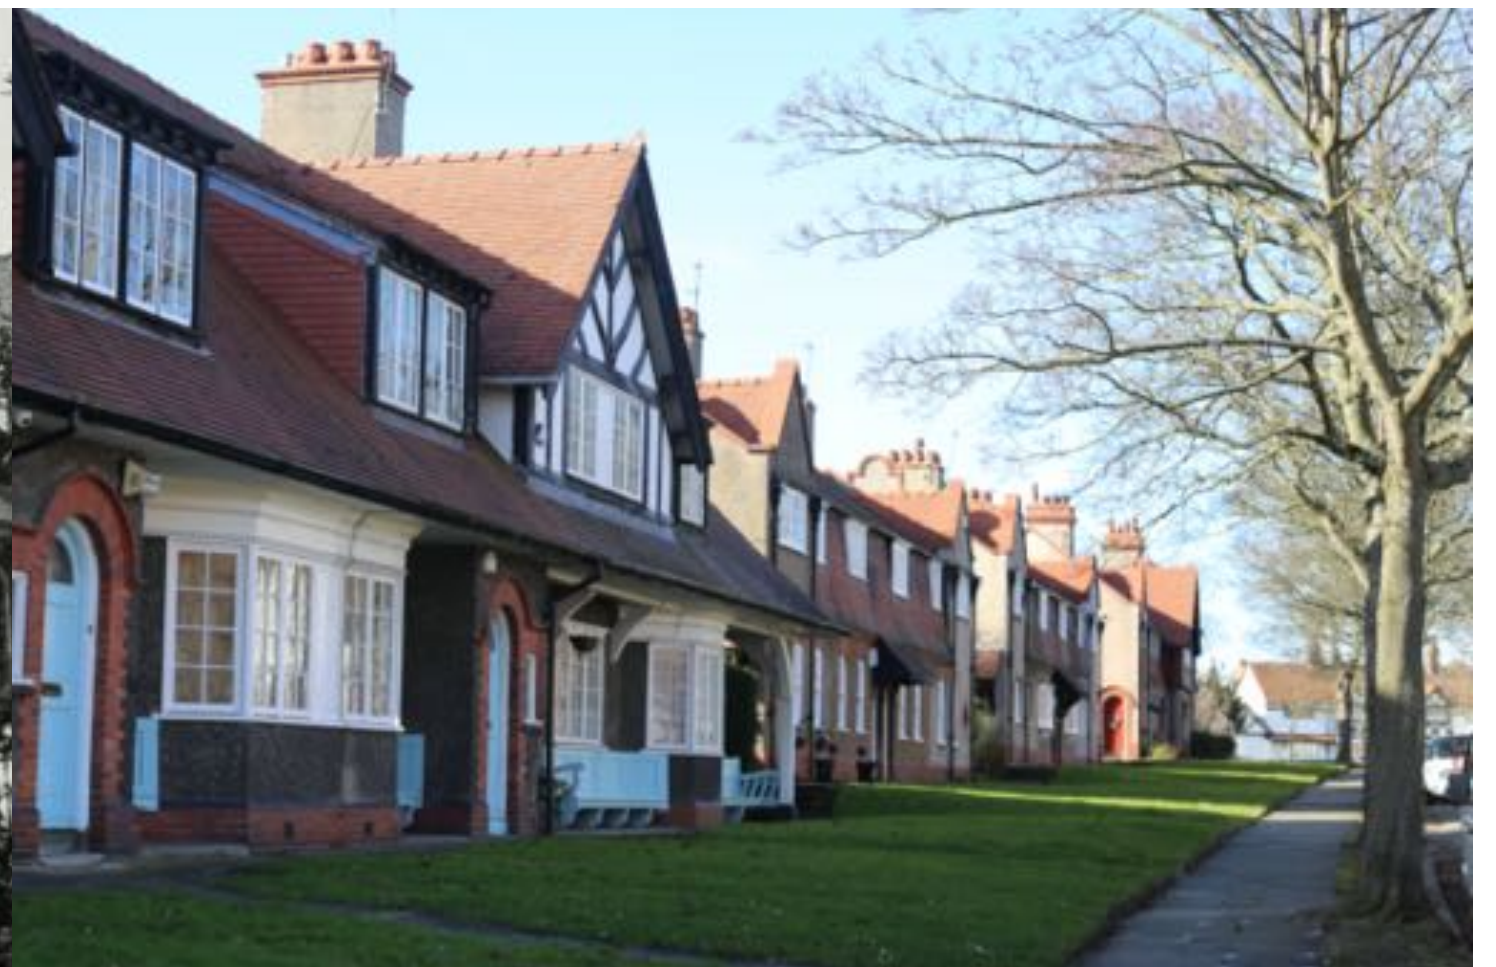
Figure 6: Pool Bank

A tree lined street with shrub planting and mid-height railings to property frontages.

Even though the view focus is on the property, it is completely different from the original design or character through the loss of landscape features, primarily the boundary railings. Maintenance of this 'new' character along Pool Bank is recommended, as this mature and simplified character works well with the architecture of the properties. Tree management is required to sustain the current tree lined street character.

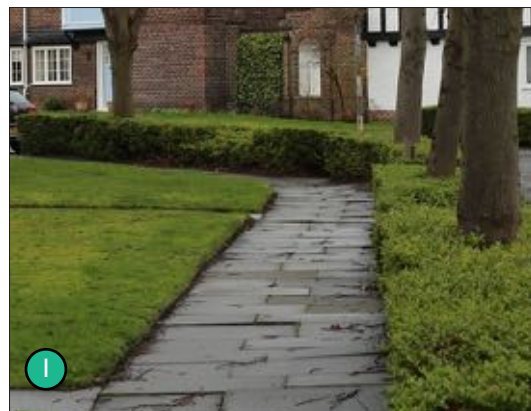
Character Area 7

Uneven paving along Windy Bank

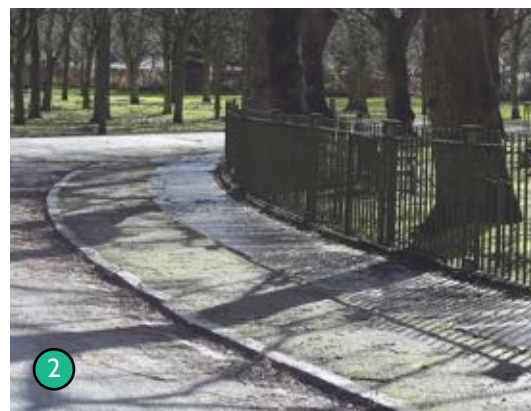
Character Area 8

Paving outside the Christ Church.

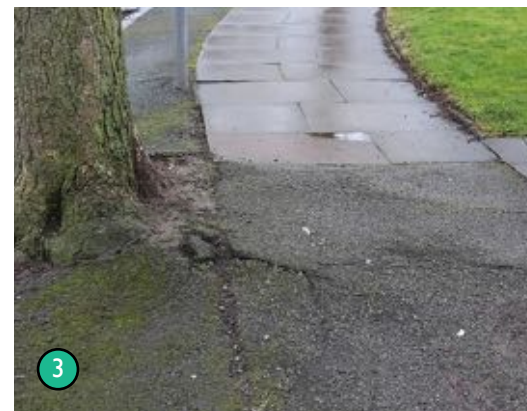
Character Area 10

Root heave damage to pavement, Church Drive.

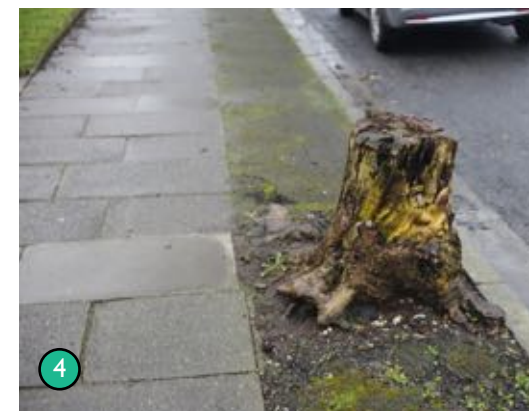
Character Area 11

Leftover tree stump, Central Road.

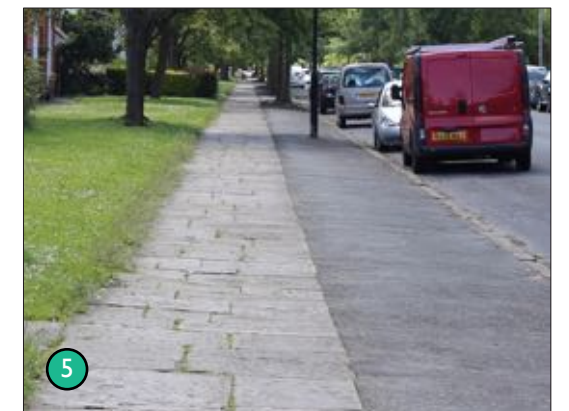
Character Area 12

Acceptable condition paving along Greendale Road

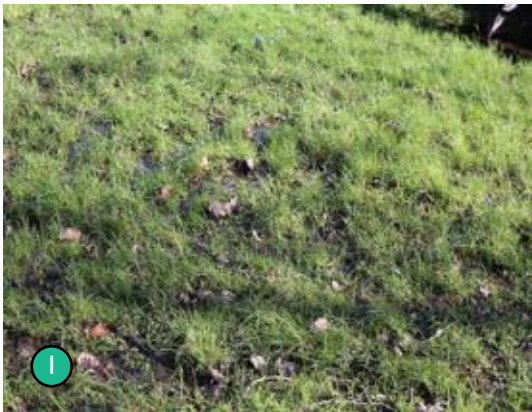
Character Area 2

Weeds in grass in front of residential properties, Park Road.

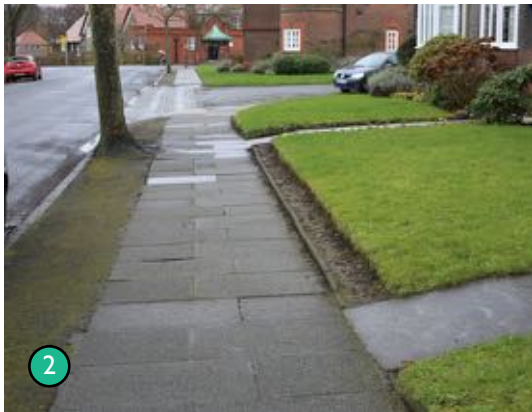
Character Area 3

Unfilled gap strip, Park Road.

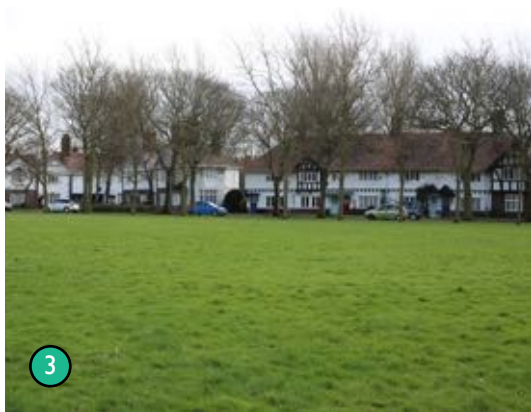
Character Area 8

Well maintained grass, playing field, the Ginnel.

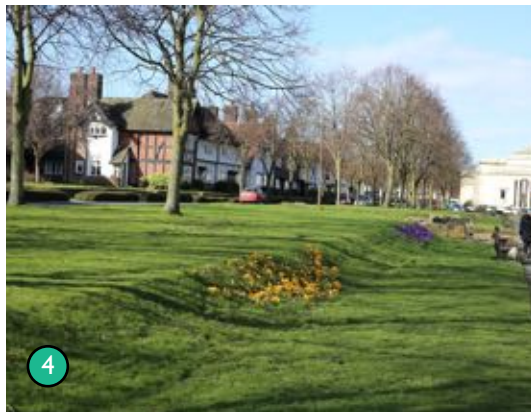
Character Area 9

Well maintained grass with crocus bulbs in the Diamond.

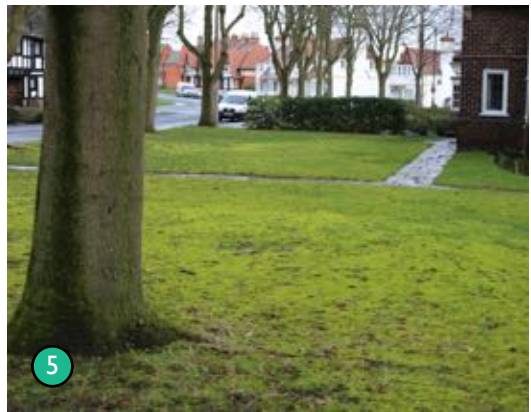
Character Area 12

Moss in grass in front of residential properties.

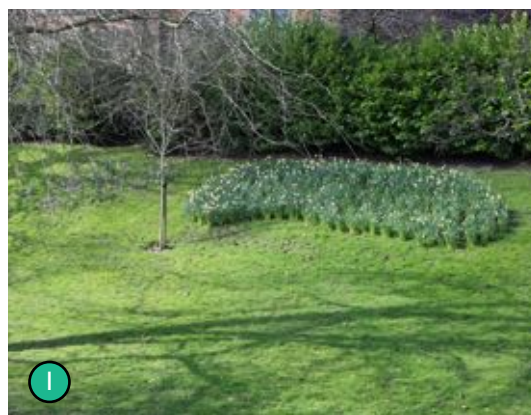
Character Area 2

Bulb planting in the Dell.

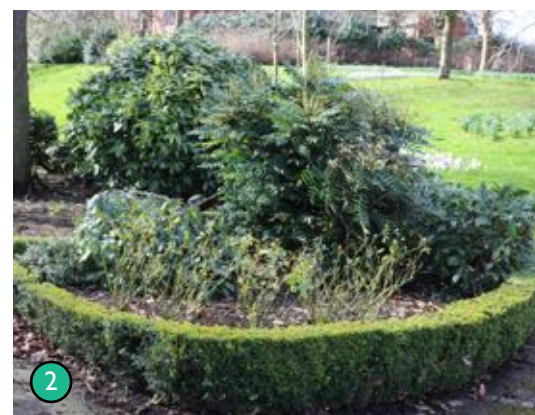
Character Area 2

Formal shrub planting in the Dell.

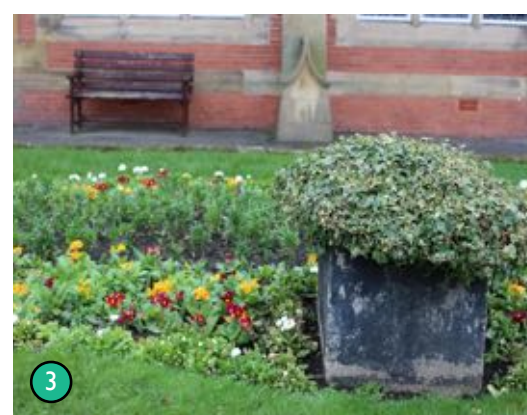
Character Area 3

Planting bed outside Hulme Hall.

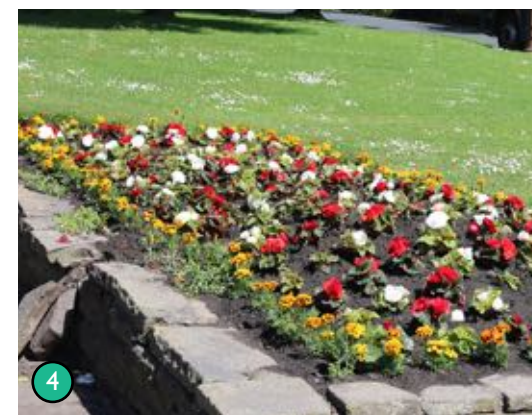
Character Area 4

Seasonal planting in the Diamond.

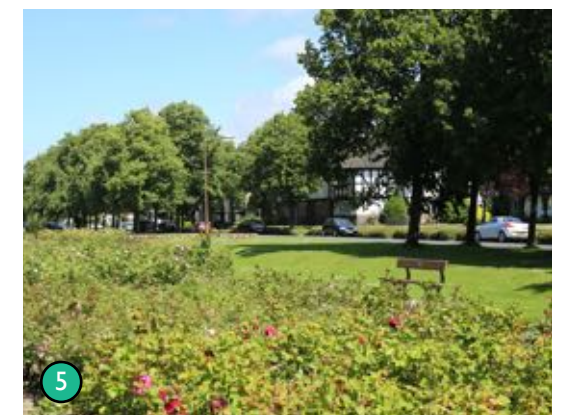
Character Area 9

Rose planting in the Diamond.

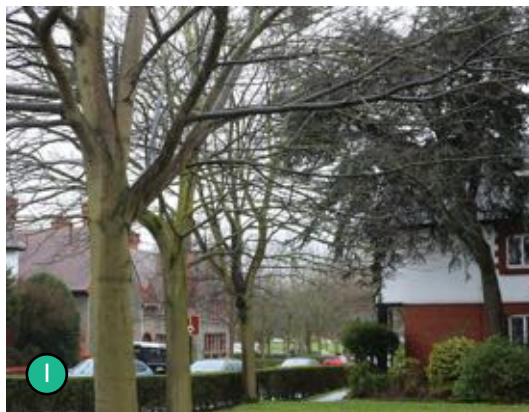
Character Area 4

Trees in soft landscape in front of residential properties.

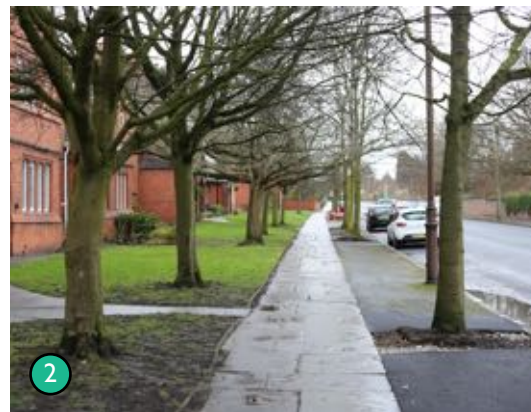
Character Area 7

Trees planted in hard landscape along Greendale Road.

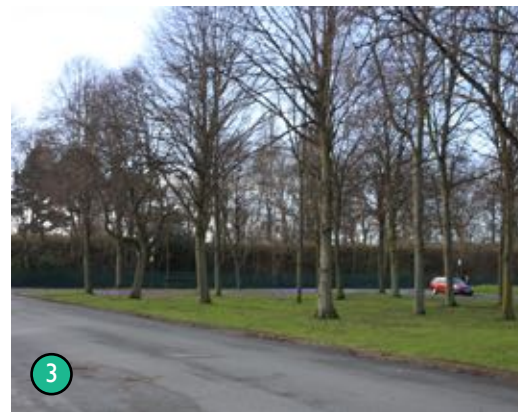
Character Area 9

Trees planted in grass, The Causeway.

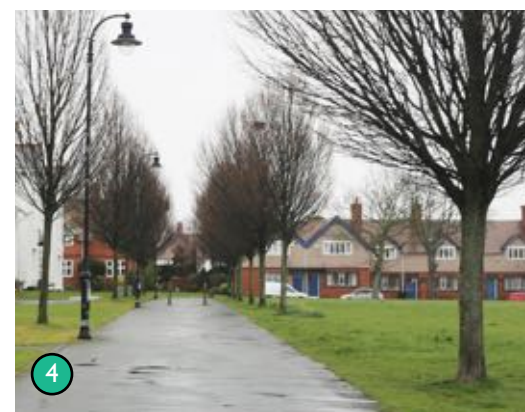
Character Area 11

Trees planted along pedestrian pathway near Osbourne Court.

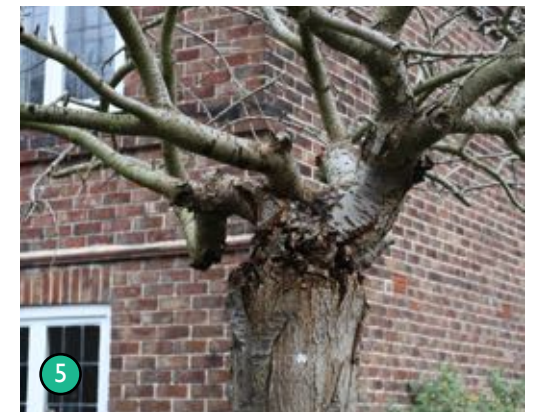
Character Area 12

Tree in poor condition on the corner of Greendale Road.

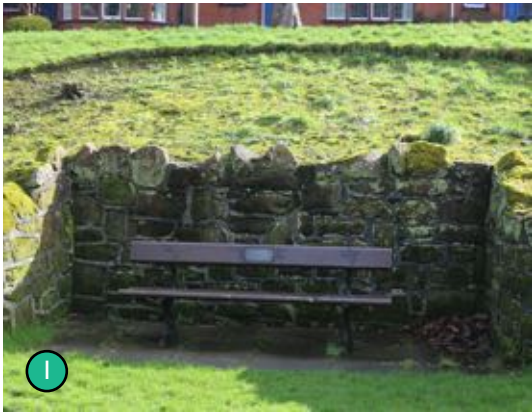
Character Area 2
Memorial bench in the Dell.

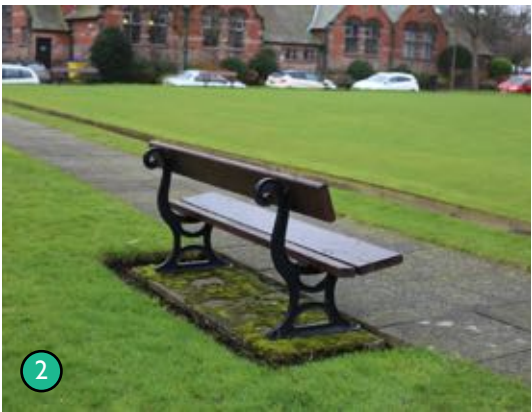
Character Area 3
Bench at the bowling green, Bath Street.

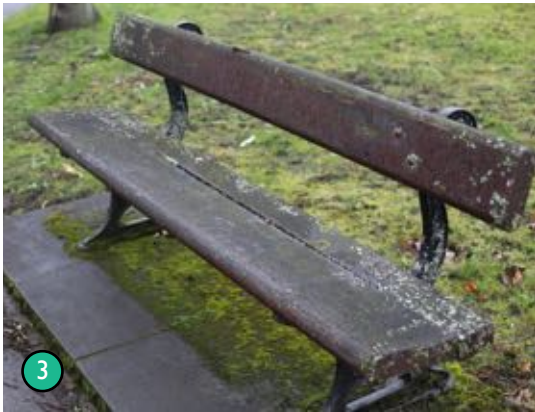
Character Area 7
Bench on raised plinth, The Causeway/ Greendale Road, causing access issues.

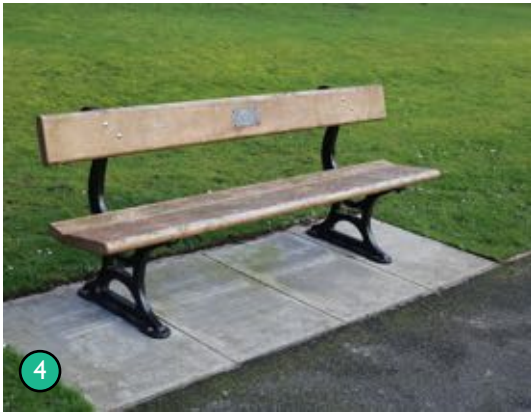
Character Area 9
Memorial Bench in the Diamond.

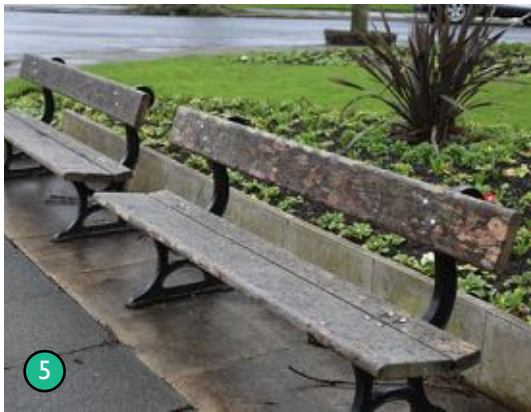
Character Area 10
Benches outside the PSVT Museum.

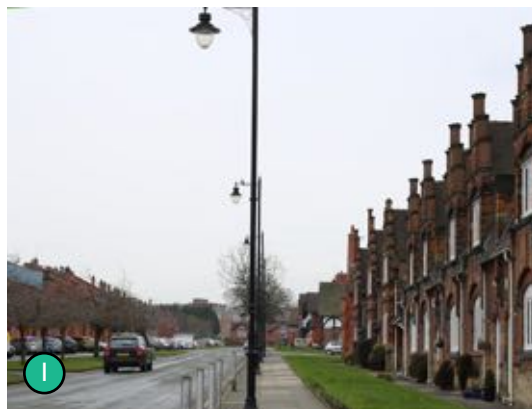
Character Area 3

Reproduction lights along Wood Street.

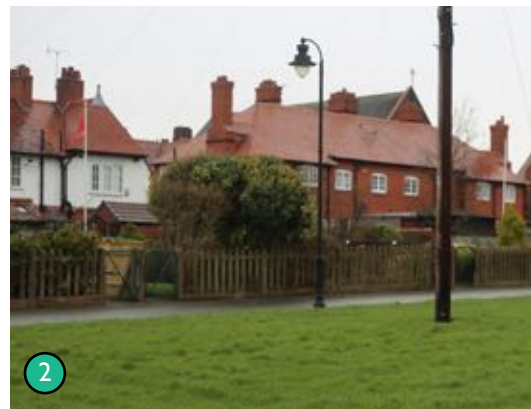
Character Area 6

Back court lamp, rear of Bebington Road properties.

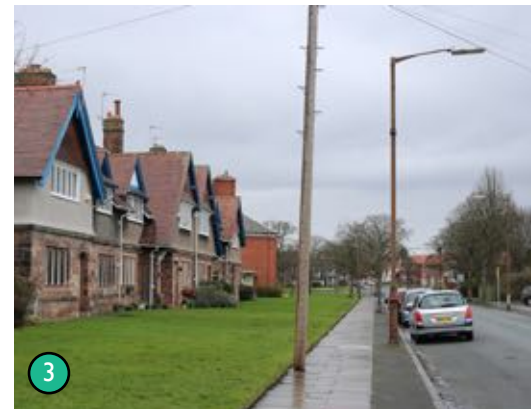
Character Area 10

Modern post and luminaire, King George's Drive.

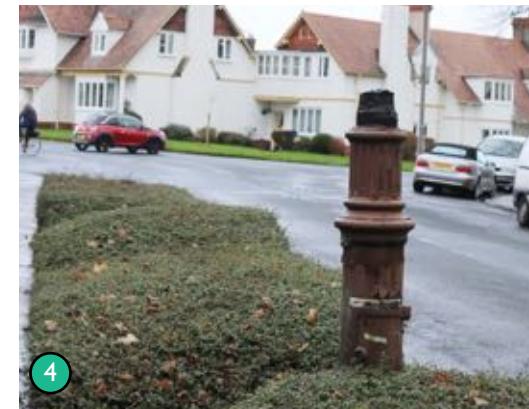
Character Area 12

Lamp post base, Primrose Hill.

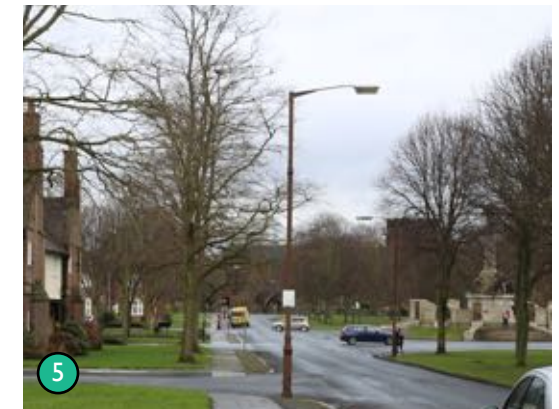
Character Area 12

Street lamp, Windy Bank.

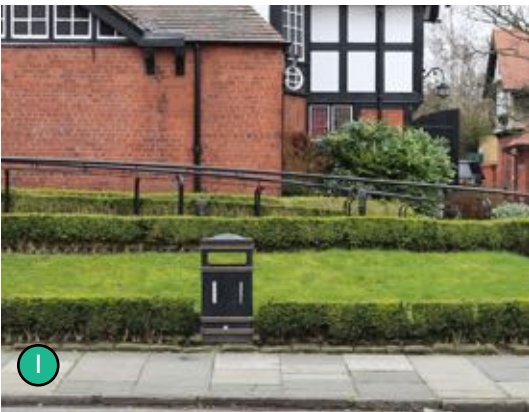
Character Area 3
Litter bin outside Gladstone Theatre.

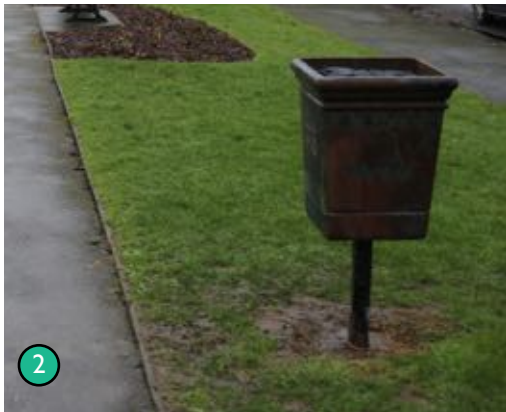
Character Area 6
Litter bin in in the bowling green.

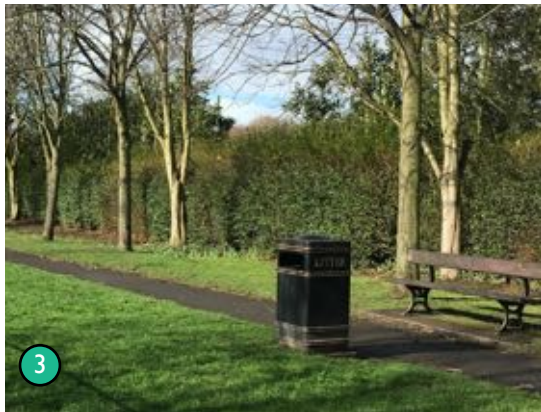
Character Area 8
Litter bin near Church Drive Primary School.

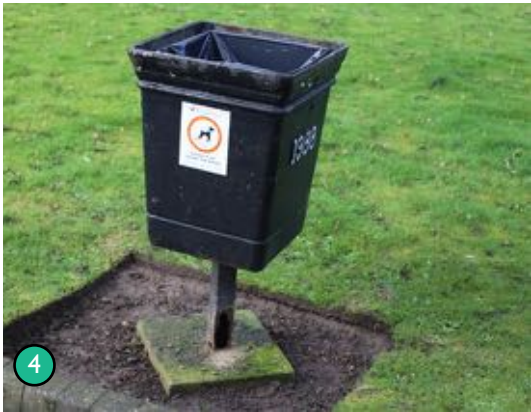
Character Area 8
Litter bin, Poets Corner.

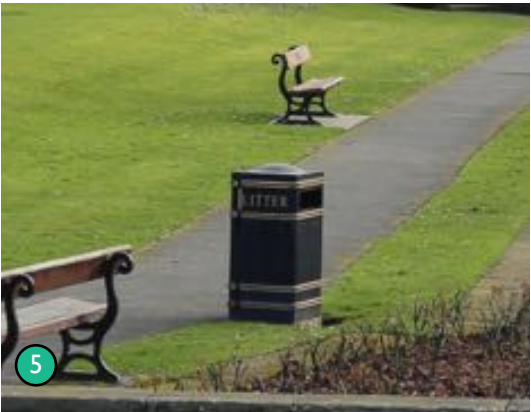
Character Area 9
Litter bin in the Diamond.

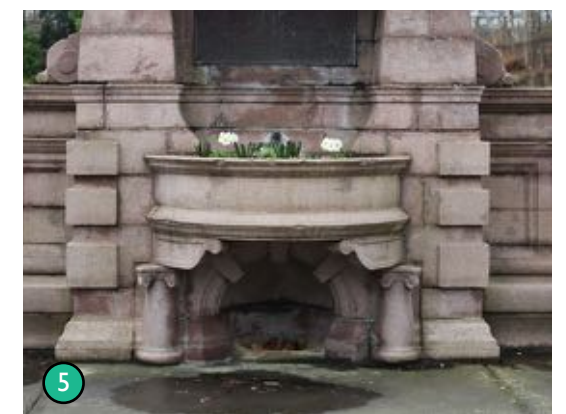
Character Area 3
Silver Wedding Anniversary Fountain

- Historic monuments are in a good condition and well maintained although clearer access is needed;
- Former fountain at the edge of bowling green in Character Area 3 requires maintenance and a review into the bedding planting as the most appropriate solution;
- Fountain in the Diamond (Character Area 9) requires maintenance and repair;
- Ground mosaic in the Diamond (Character Area 9) in degraded condition;
- Artwork concentrated to the more active visitor core; and
- Wall features in Character Area 12 require maintenance.

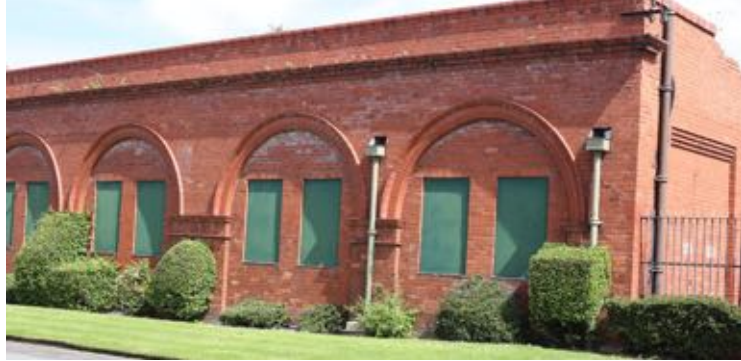
Planting Review, Strategy & Maintenance

Short Term	Planting Condition Review and Strategy: A full survey of all planting beds including condition, health, vigour and longevity for simplification of planting styles/ initiatives to reduce long term maintenance activities: <ul style="list-style-type: none">• Cut back or removal of overly mature stock;• Removal of failing/empty beds (over 75%) and remediation; and• Infilling beds with less than 25% plants missing;
	Tree Management: Tree Survey of all trees, ideally annually, for pruning, crown lifting, height reduction, thinning or selective removal.
Intermediate Term	<i>All above actions ongoing to completion.</i>
	Pavements: Review with WMBC into a strategic pavement improvement programme with particular regard to public Health and Safety.
Long Term	<i>All above actions ongoing on a cyclical basis</i>
	-
