Port Sunlight Landscape Condition Survey Report

Port Sunlight Village Trust

Prepared by Ryder Landscape Consultants

July 2017

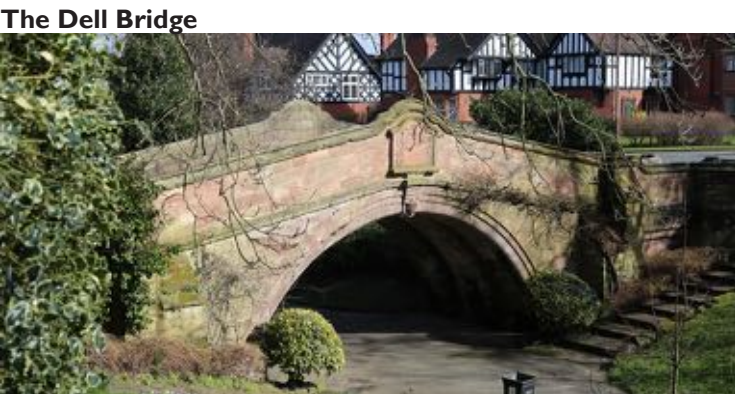
Drainage and Flooding/ Street Furniture

Drainage and Flooding: Commission a full hydrological and drainage survey of the Dell to base recommendations to tackle flooding upon. Development of a plant species list which can withstand damp/ wet conditions for inclusion, where appropriate.

Street Furniture (e.g. benches, bins, signs, etc.): Initiate a strategy and programme of street furniture maintenance activities including cleaning, painting or replacement if repair is not economically viable.

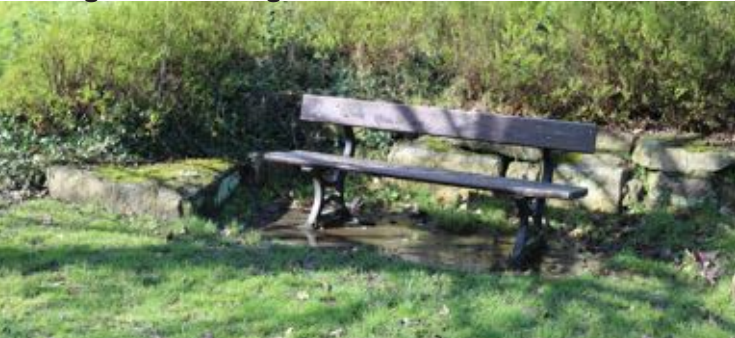
Planting Review, Strategy & Maintenance

Planting Condition Review and Strategy: A full survey of all planting beds including condition, health, vigour and longevity for simplification of planting styles/ initiatives to reduce long term maintenance activities:

- Identify any heritage planting;
- Cut back or removal of overly mature species;
- Removal of failing/empty beds (over 75%) and remediation;
- Infilling beds with less than 25% missing; and
- Removal of small scale planting initiatives such as box hedging and roses beds.

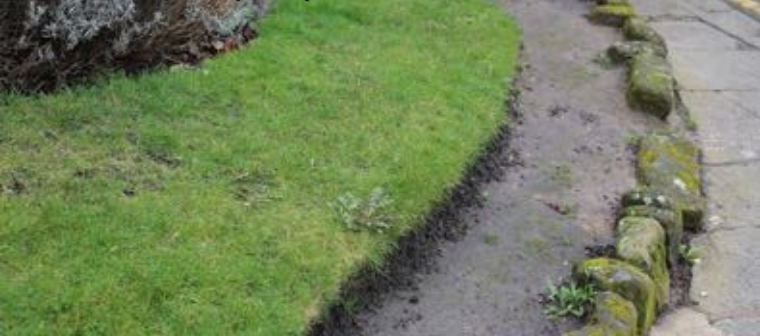
Infill of Unfilled Gap Strips

Short Term	Bowling Greens: Greendale Road Discussions with Bowling Green clubs/users for additional funding for the maintenance of the greens – particularly Greendale Road, as used for league matches. Potential improvement to planted banks.
	Infill of Unfilled Edging Strips: Strategy and implementation for the infill of unfilled gap strips along all roads. Example: infilled with top soil and grass turf. The area to be protected and watered regularly during establishment.
	Planting Condition Review and Strategy: A full survey of all planting beds including condition, health, vigour and longevity for simplification of planting styles/ initiatives to reduce long term maintenance activities: <ul style="list-style-type: none">• Removal of failing/empty beds (over 75%) and remediation;• Infilling beds with less than 25% missing; and• Removal of small scale planting initiatives such as rose beds and a rationalisation of box hedging at Gladstone Theatre.

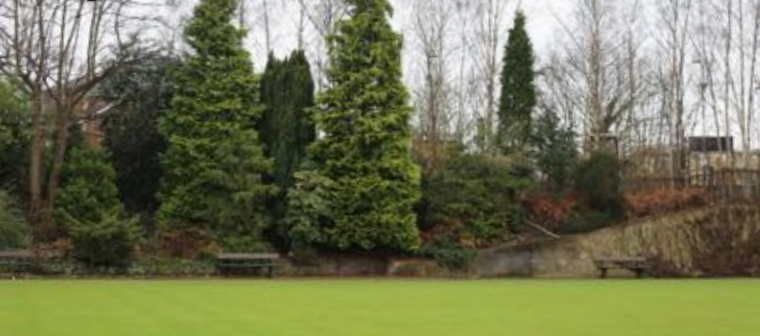
Bowling Greens

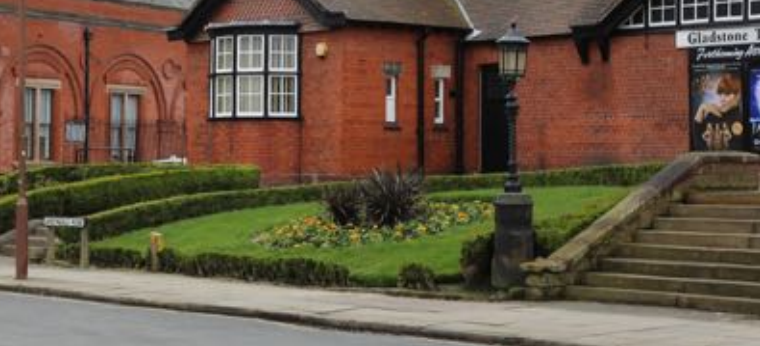
Planting Review, Strategy & Maintenance: Gladstone Theatre

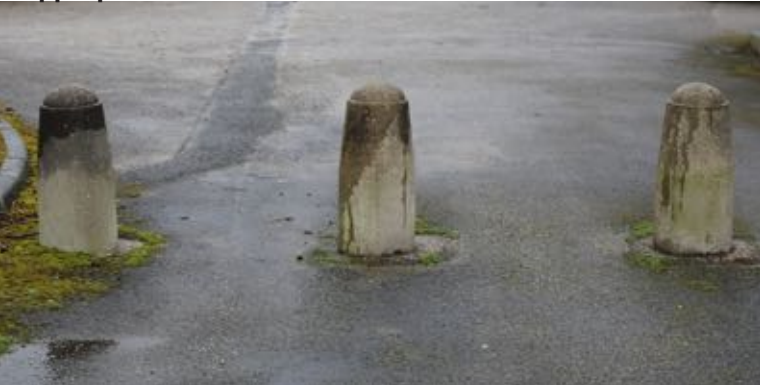
Inappropriate Bollards

- All above actions ongoing to completion, plus:*
- Bollards:** Review with WMBC into suitable bollard to use throughout the village that is appropriate to the conservation area and heritage setting. Strategic replacement of inappropriate bollards, starting with the most obvious.
- Hedges:** Review and remove all miscellaneous items located within hedges to aid ease of maintenance activities.
- Pavements:** Review with WMBC into a strategic pavement improvement programme with particular regard to public Health and Safety.

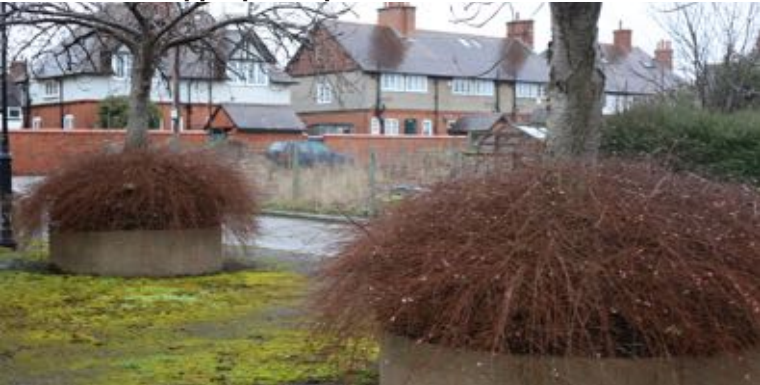
Removal of inappropriate planters

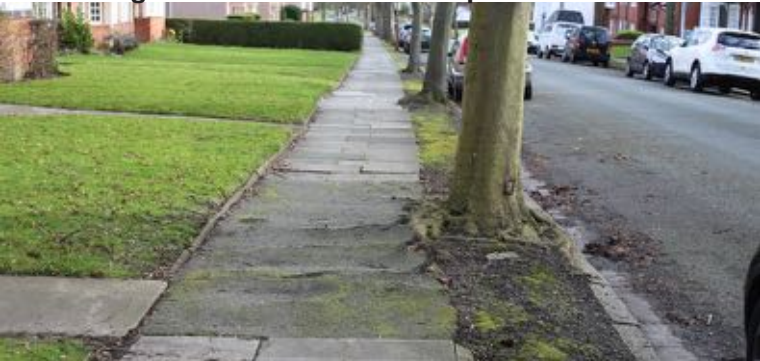
Tree Management: Root heave of footpaths

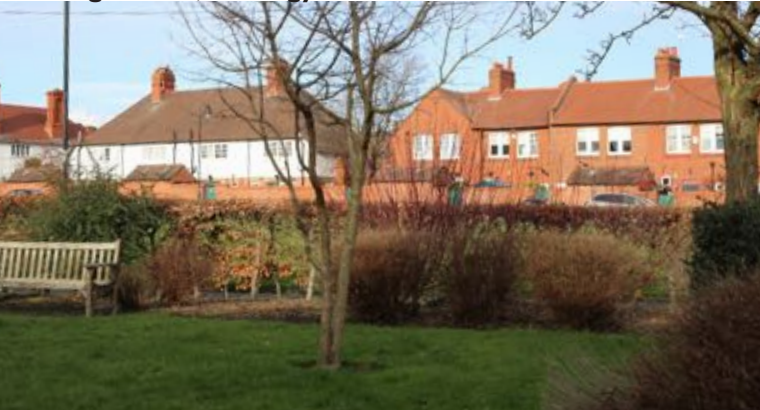
Planting Review, Strategy and Maintenance

Planting Condition Review and Strategy: A full survey of all planting beds including condition, health, vigour and longevity for simplification of planting styles/ initiatives to reduce long term maintenance activities:

- Removal of failing/empty beds (over 75%) and remediation;
- Infilling beds with less than 25% missing; and
- Removal of aggressive hedge species is e.g. Rosa and replaced with slow growing low maintenance ground cover species – if appropriate.

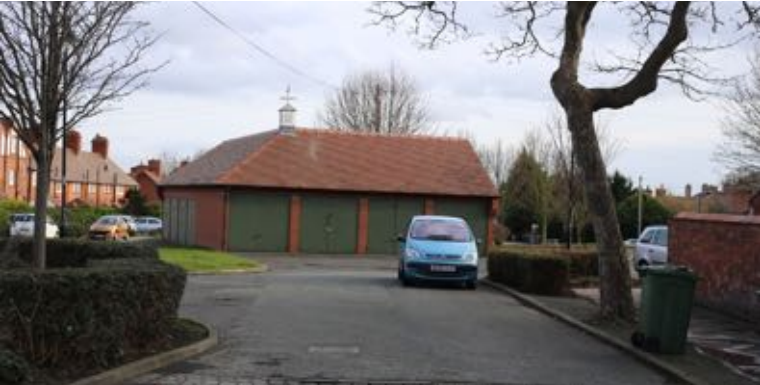
Rationalisation of Block Back Courts

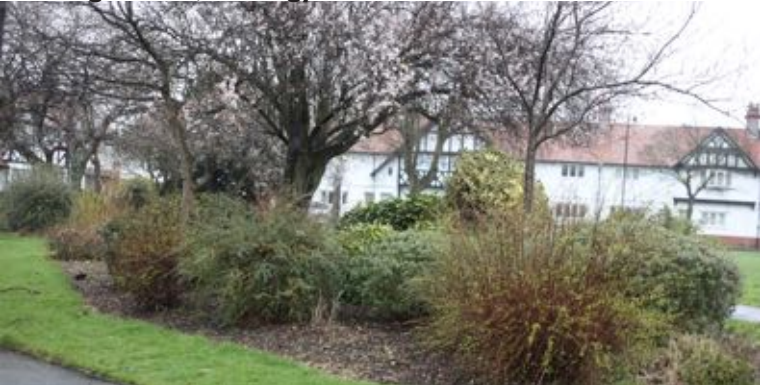
Planting Review, Strategy & Maintenance

Planting Condition Review and Strategy: A full survey of all planting beds including condition, health, vigour and longevity for simplification of planting styles/ initiatives to reduce long term maintenance activities:

- Removal of failing/empty beds (over 75%) and remediation;
- Infilling beds with less than 25% missing; and
- Removal of aggressive hedge species is e.g. Rosa and replaced with slow growing low maintenance ground cover species – if appropriate.

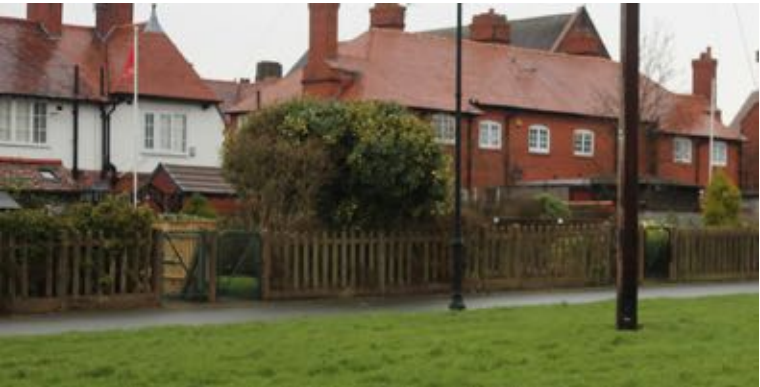
Boundary Fencing

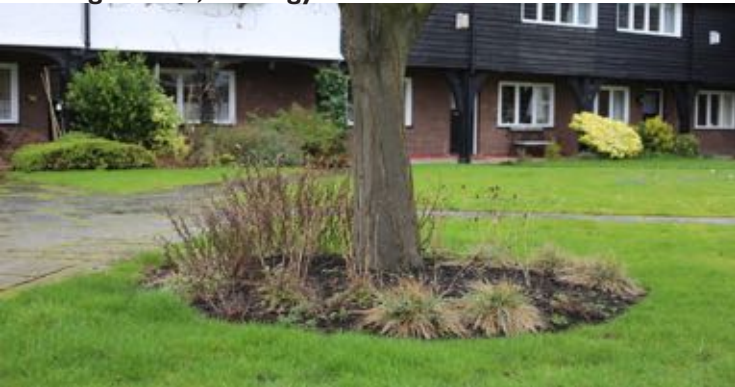
Planting Review, Strategy & Maintenance

Short Term	Infill of Unfilled Edging Strips: Strategy and implementation for the infill of unfilled gap strips along all roads. Example: infilled with top soil and grass turf. The area to be protected and watered regularly during establishment.
	Planting Condition Review and Strategy: A full survey of all planting beds including condition, health, vigour and longevity for simplification of planting styles/ initiatives to reduce long term maintenance activities: <ul style="list-style-type: none">• Removal of failing/empty beds (over 75%) and remediation;• Infilling beds with less than 25% missing;• Removal of small scale planting initiatives such as box hedging and roses beds; and• Removal of planting near garage blocks to increase public safety.
	Street Furniture (e.g. benches, bins, signs, etc.): Initiate a strategy and programme of street furniture maintenance activities including cleaning, painting or replacement if repair is not economically viable.

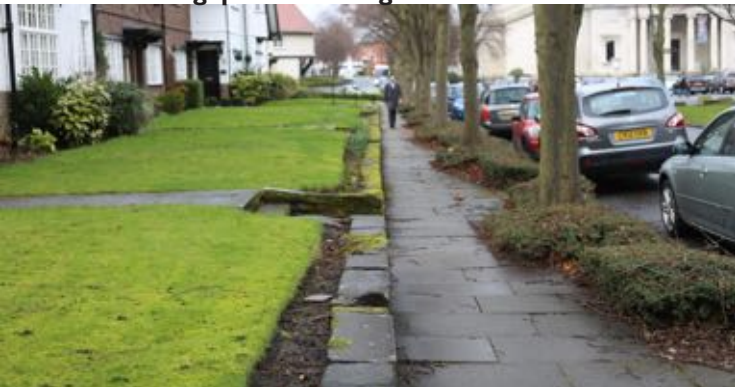
Infill of unfilled gap/ Tree Management

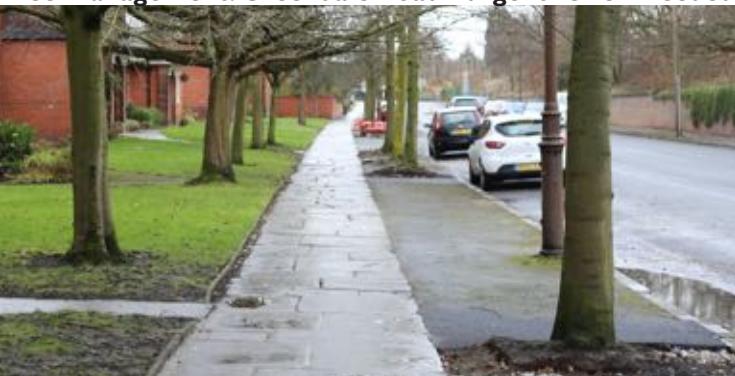
Tree management: Greendale Road - urgent review needed

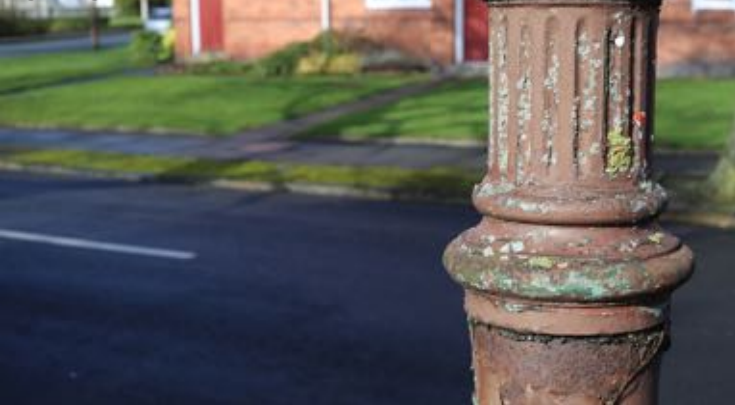
Lighting Columns

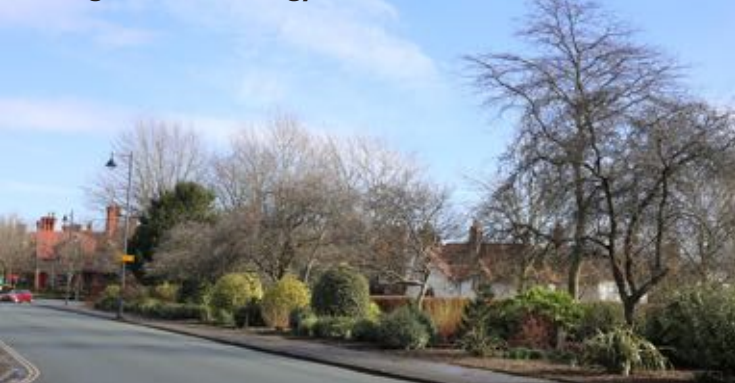
Planting Review, Strategy & Maintenance

Short Term	Infill of Unfilled Edging Strips: Strategy and implementation for the infill of unfilled gap strips along all roads. Example: in filled with top soil and grass turf. The area to be protected and watered regularly during establishment.
	Planting Condition Review and Strategy: A full survey of all planting beds including condition, health, vigour and longevity for simplification of planting styles/ initiatives to reduce long term maintenance activities: <ul style="list-style-type: none">• Cut back or removal of overly mature species;• Removal of failing/empty beds (over 75%) and remediation;• Infilling beds with less than 25% missing;• Removal of small scale planting initiatives such as box hedging and roses beds; and• Removal of planting near garage blocks to increase public safety.
	Street Furniture (e.g. benches, bins, signs, etc.): Initiate a strategy and programme of street furniture maintenance activities including cleaning, painting or replacement if repair is not economically viable.

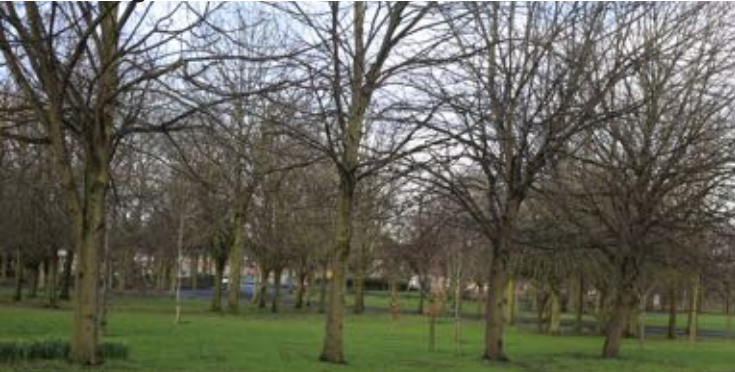
Tree Management

Tree Management: Survey of all trees annually, for pruning, crown lifting, height reduction, thinning or selective removal, particularly Poplar trees along Church Drive. Review with WMBC into root heave long footpaths. Strategic removal and remediation under public Health and Safety.
Intermediate Term	<i>All above actions ongoing to completion, plus:</i>
	Bollards and Lighting Columns: Review with WMBC into suitable bollard and lighting columns to use throughout the village that are appropriate to the Conservation Area and heritage setting. Initiate strategic replacement of inappropriate bollards and lighting columns.
	Church Drive School Railings: Repainting and repair of railings.
	Pavements: Review with WMBC into a strategic pavement improvement programme with particular regard to public health and safety.
Long Term	Signage Strategy: Review of signage survey and drafting strategy.
	<i>All above actions ongoing to completion, plus:</i>

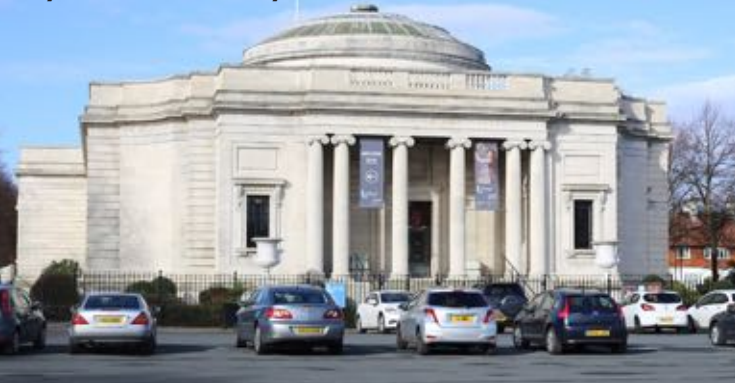
Lady Lever Art Gallery Plaza

Initiate re-development of plaza space in front of the Lady Lever Art Gallery, in full association with WMBC. Proposals to include the removal of ad hoc paving, creating pedestrian hierarchy and a rationale for visitor parking that allows the building and avenue views to be better appreciated.

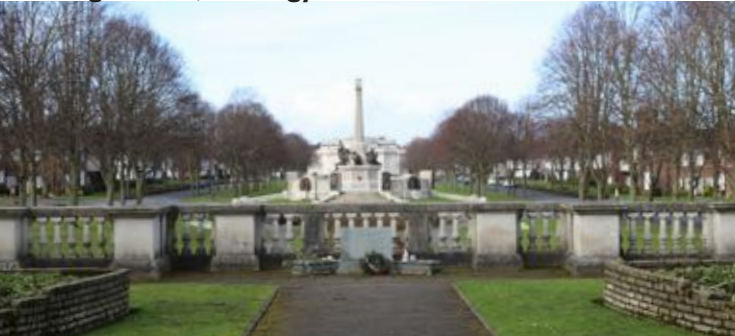
Planting Review, Strategy & Maintenance

- A full survey of all planting beds including condition, health, vigour and longevity for simplification of planting styles/ initiatives to reduce long term maintenance activities:
- Removal of failing/empty beds (over 75%) and remediation;
 - Removal of small scale planting initiatives such as box hedging and roses beds; and
 - Infilling beds with less than 25% missing.
- Street Furniture (e.g. benches, bins, signs, etc.):** Initiate a strategy and programme of street furniture maintenance activities including cleaning, painting or replacement if repair is not economically viable.
- Tree Management:** Survey of all trees annually, for pruning, crown lifting, height reduction, thinning or selective removal, Review with WMBC into root heave long footpaths. Strategic removal and remediation under public Health and Safety.

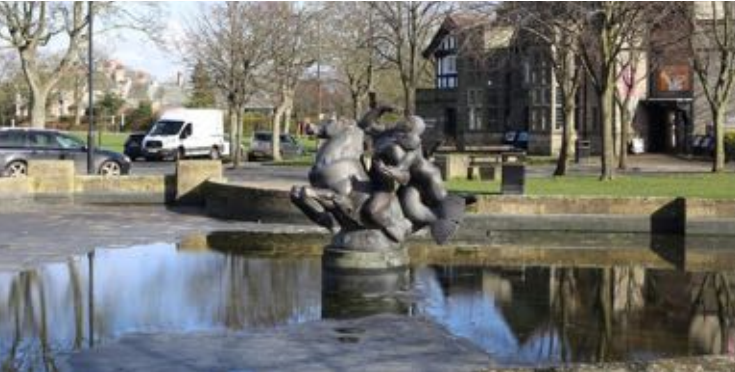
Sea Piece Fountain

A full condition survey for the fountain and surrounding pool leading to restoration keeping the fountain as a key village feature and improving the ease of ongoing maintenance.

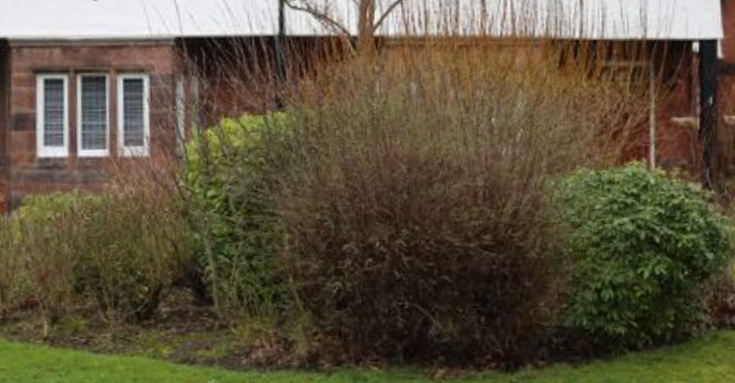
Planting Review, Strategy & Maintenance

Planting Condition Review and Strategy: A full survey of all planting beds including condition, health, vigour and longevity for simplification of planting styles/ initiatives to reduce long term maintenance activities:

- Removal of failing/empty beds (over 75%) and remediation; and
- Infilling beds with less than 25% missing.

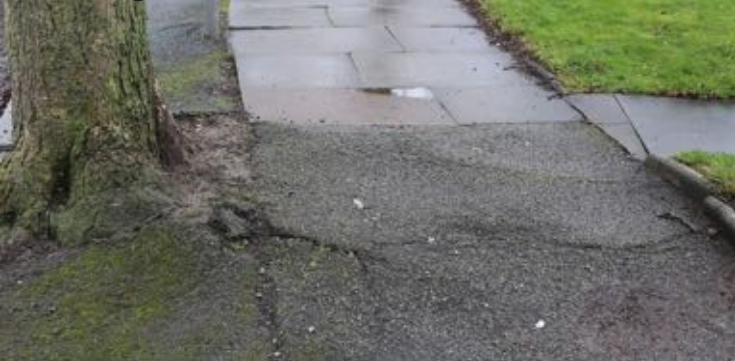
Tree Management

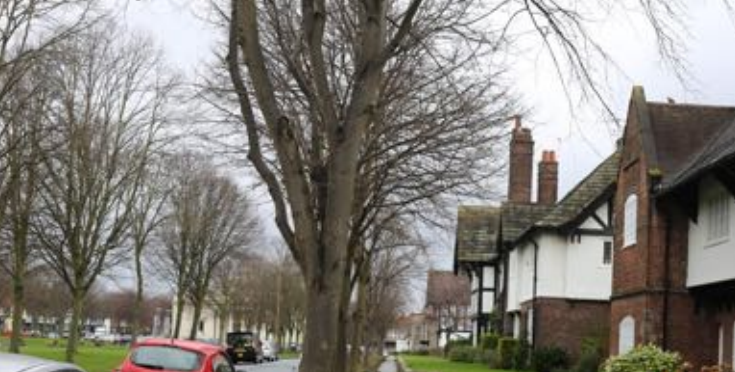
Tree Management

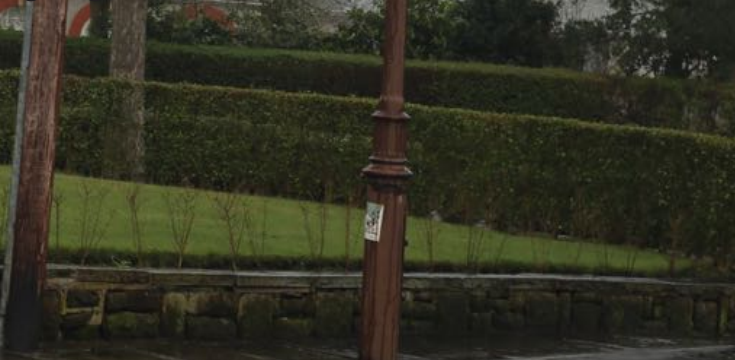
Lighting Columns Review

Bollards and Lighting Columns: Review with WMBC into suitable bollard and lighting columns to use throughout the village that are appropriate to the Conservation Area and heritage setting. Initiate strategic replacement of inappropriate bollards and lighting columns.

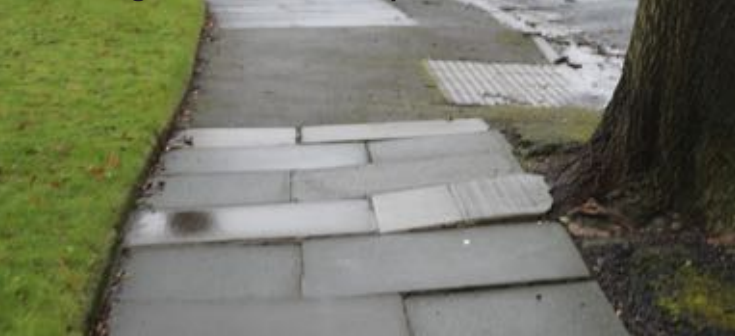
Tree Management - root heave pictured

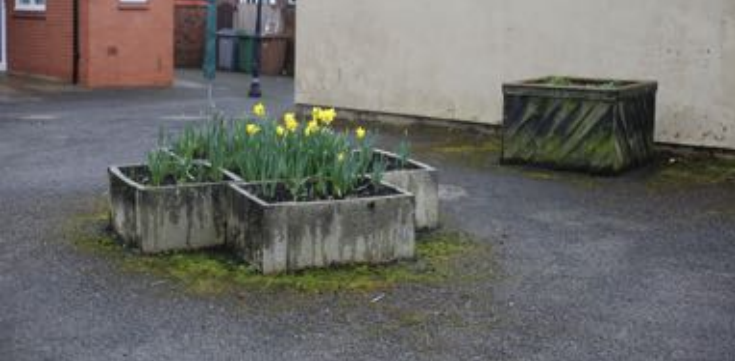
Removal of inappropriate planters

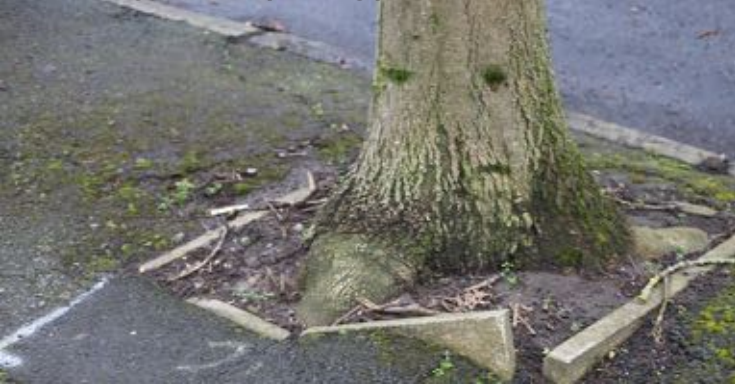
Tree Management at planting pit

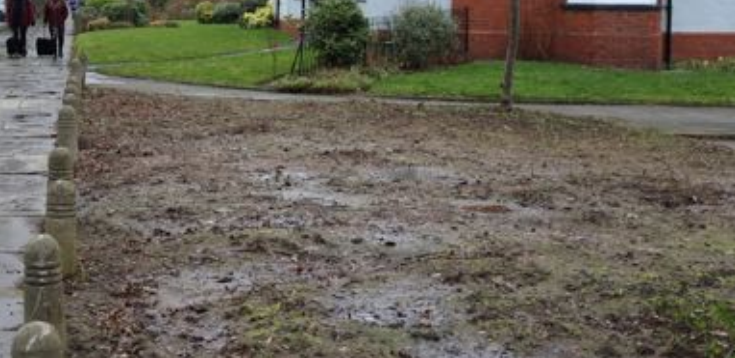
Planting Review, Strategy & Maintenance

Short Term	<p>Planting Condition Review and Strategy: A full survey of all planting beds including condition, health, vigour and longevity for simplification of planting styles/ initiatives to reduce long term maintenance activities:</p> <ul style="list-style-type: none">• Removal of failing/empty beds (over 75%) and remediation;• Removal of planting near garage blocks to increase public safety. and• Infilling beds with less than 25% missing. <p>Street Furniture (e.g. benches, bins, signs, etc.): Initiate a strategy and programme of street furniture maintenance activities including cleaning, painting or replacement if repair is not economically viable.</p> <p>Tree Management: Survey of all trees annually, for pruning, crown lifting, height reduction, thinning or selective removal. Review with WMBC into root heave long footpaths. Strategic removal and remediation for public Health and Safety reasons.</p>

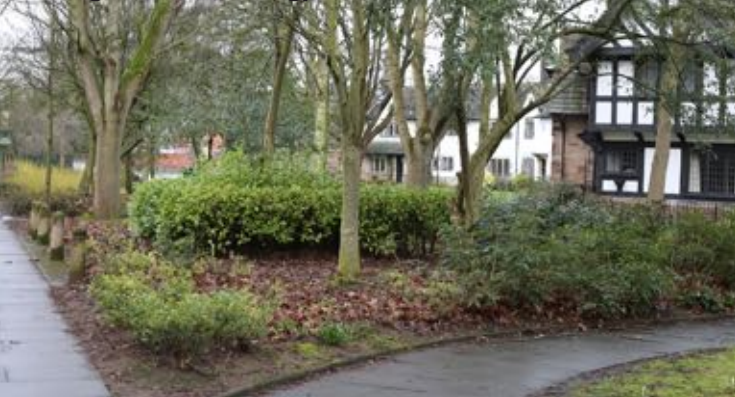
Planting Review, Strategy & Maintenance

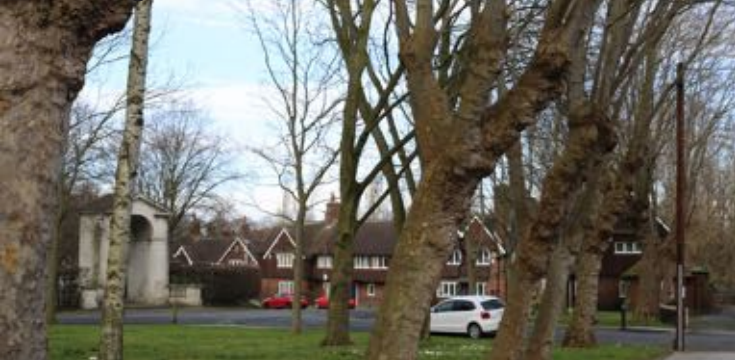
Tree Management

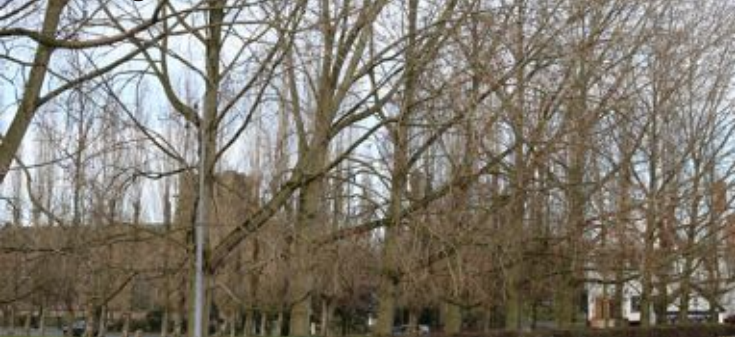
Tree Management

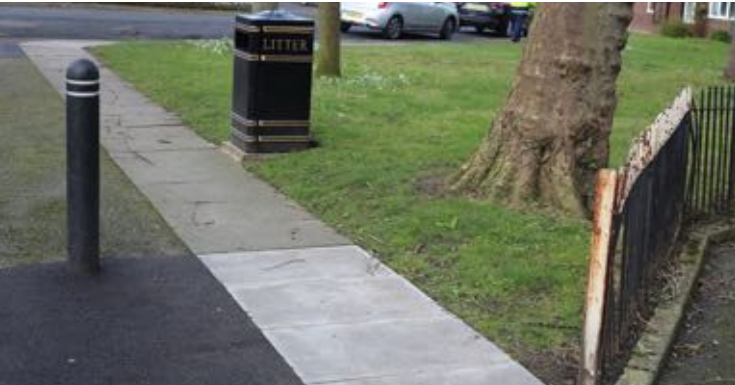
Pavements Review

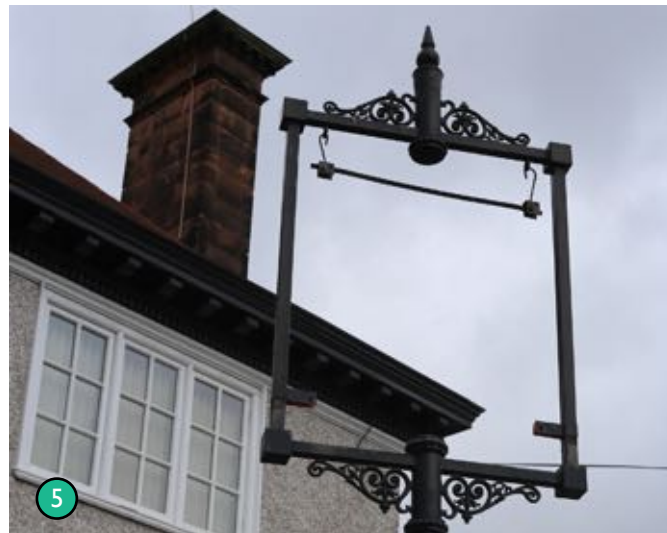
Character Area 6
Incomplete sign, New Chester Road

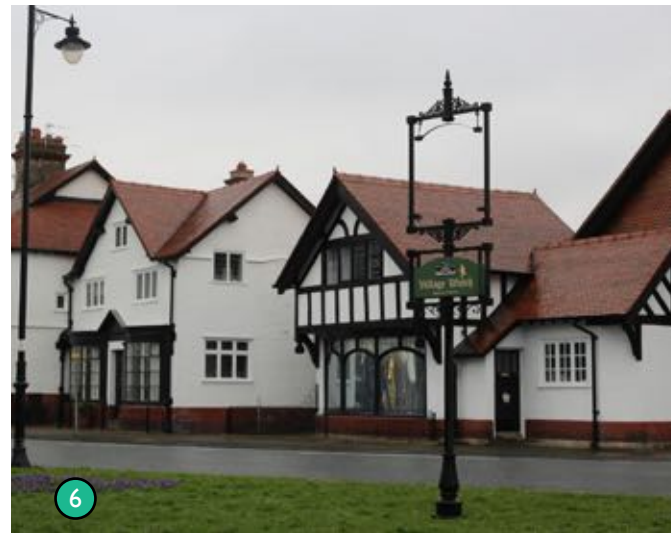
Character Area 6
Incomplete name sign, Bowling Green

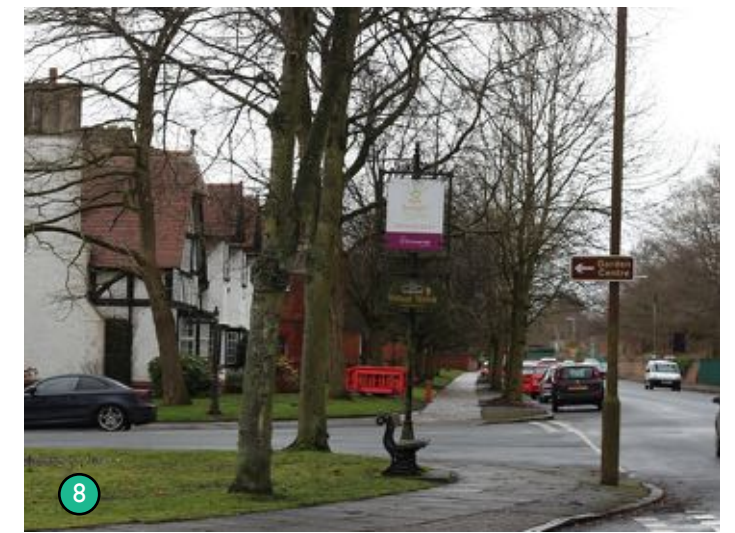
Character Area 7
Garden Centre navigation signs, Greendale Road/The Causeway

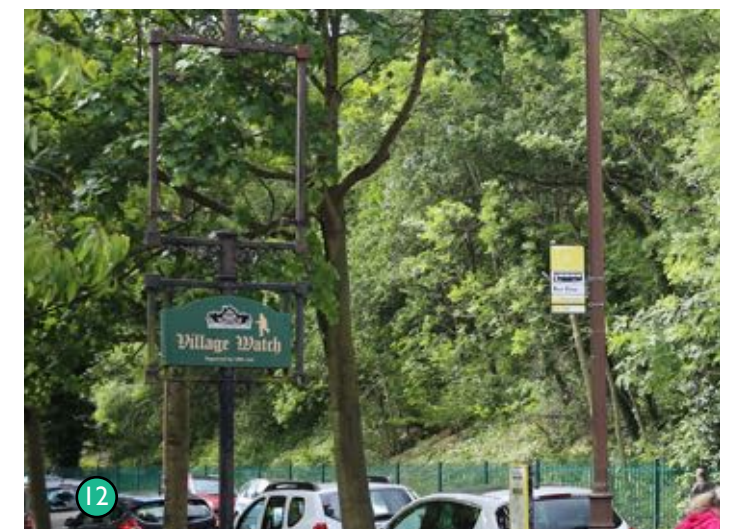
Character Area 12
Incomplete name sign, Greendale Road

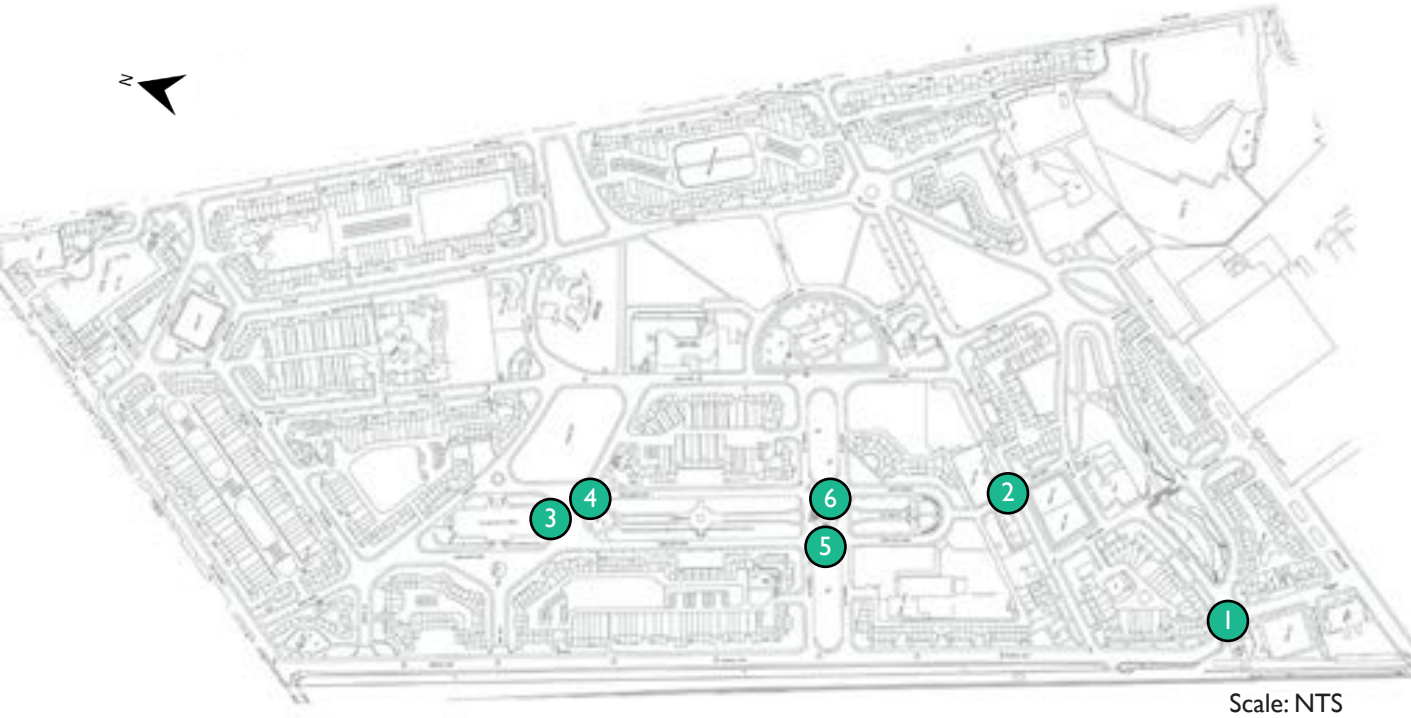
These photos indicate the lack of clear orientation or legibility around the site to key locations such as the railway station, Lady Lever Art Gallery or the Port Sunlight Village Trust Museum; and lack of orientation at main roads.

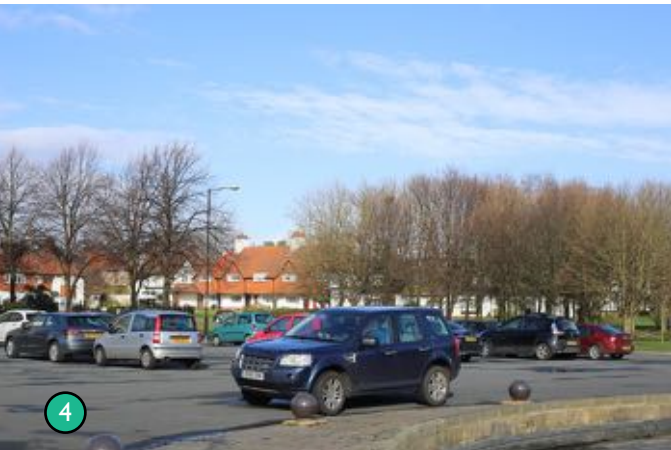
Character Area 9
Informal parking outside the Diamond

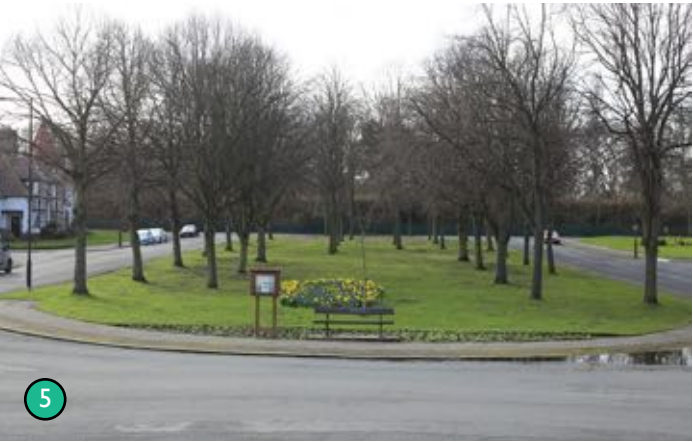
Character Area 9
The Causeway - lack of pedestrian navigation (for road crossing) or road markings for vehicle users

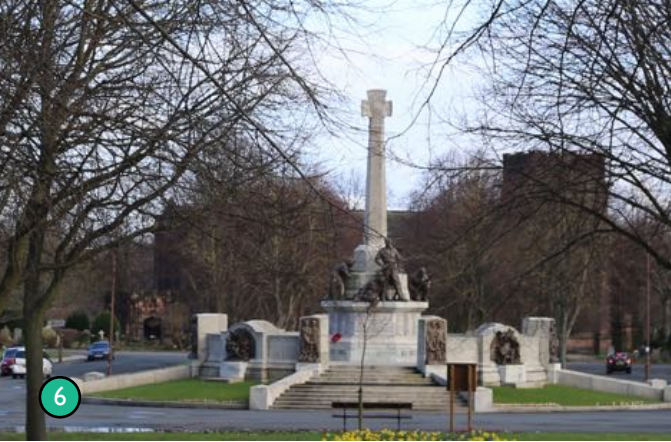
Character Area 9
The War Memorial - lack of pedestrian navigation (for road crossing) or road markings for vehicle users

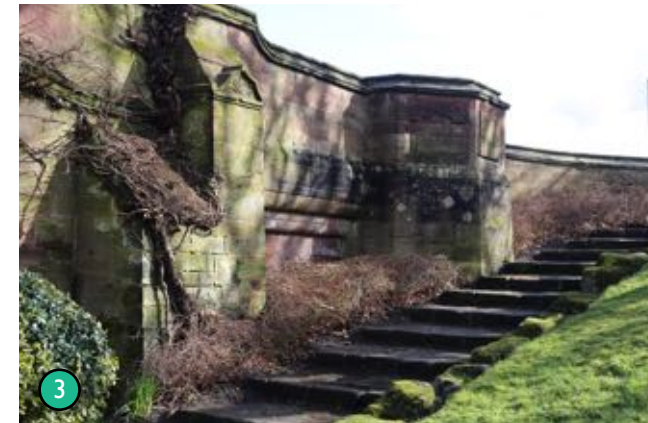
Character Area 2
Steps into the Dell - trip/slip hazard

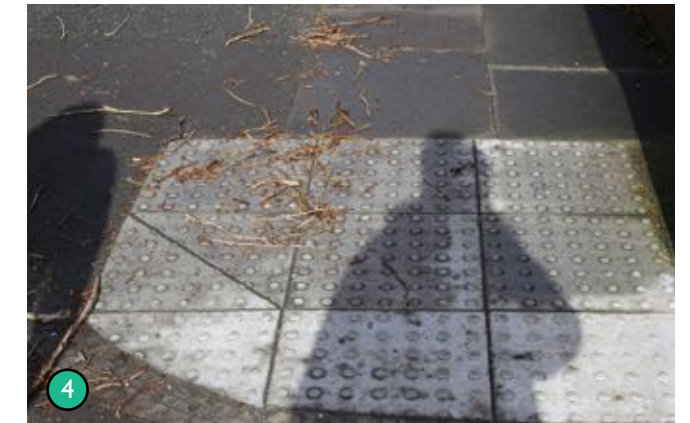
Character Area 2
Steps into the Dell - trip/slip hazard

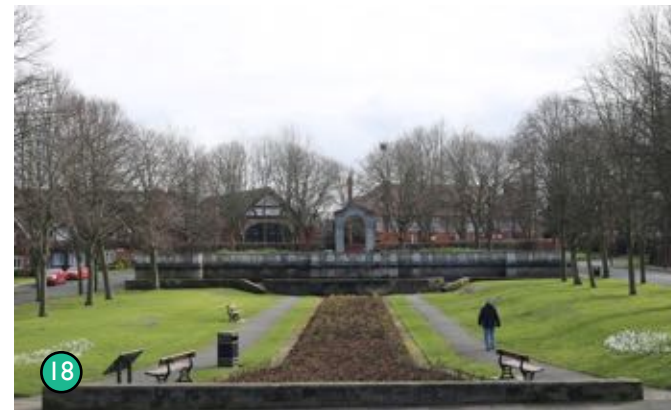
Character Area 9
Lack of DDA compliant pedestrian access to the western part of the Causeway

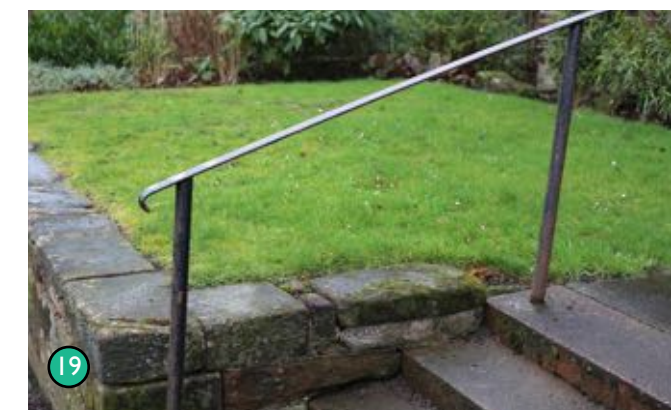
Character Area 9
Lack of DDA compliant access to the southern part of the Diamond

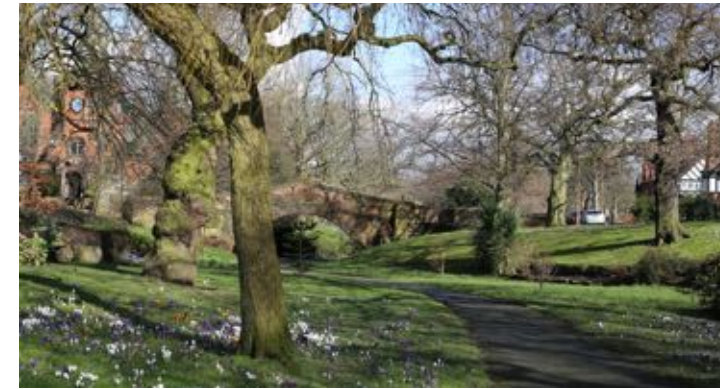
The Dell (West end): Formally laid out gardens prone to drainage issues more than the Dell mid-section or east end. Due to the proximity of social activities along Greendale Road and more established 'garden style' planting it is deemed to have less potential for biodiversity improvement.

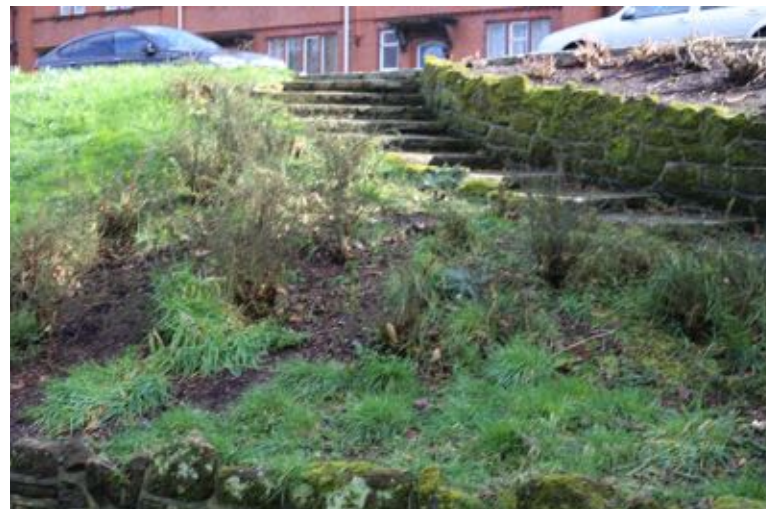
The Dell (mid-section)

The Dell (mid-section): The lowest part of the Dell, prone to drainage issues with planting failings and or large gaps.

- Wildflower meadow (suitable for wet/damp conditions);
- Box hedging surrounds the space, is a high maintenance activity in terms of pruning;
- Infill planting (different species) within hedge gaps; and
- Reduction in hedge maintenance to encourage wildlife habitat creation.

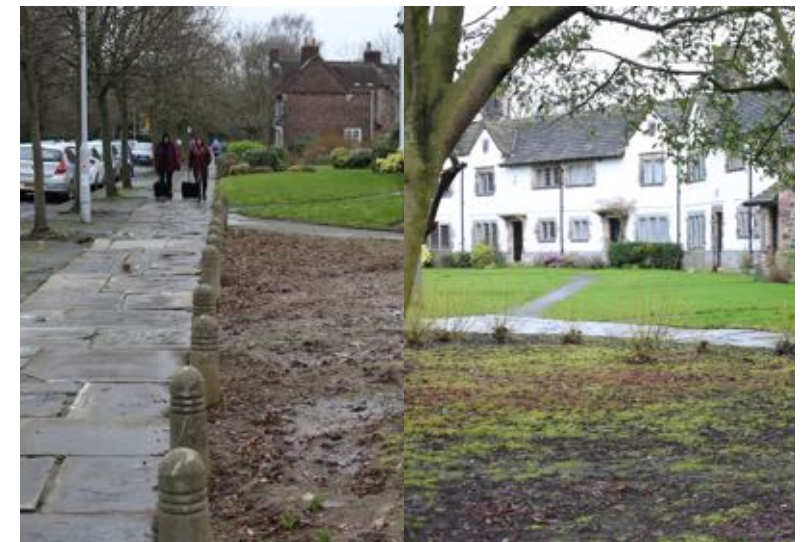
Greendale Road

Duke of York Cottages/ Greendale Road: Amenity planting in a poor condition with empty planting beds and heavily pruned shrubs.

- Appropriate groundcover shrub planting.

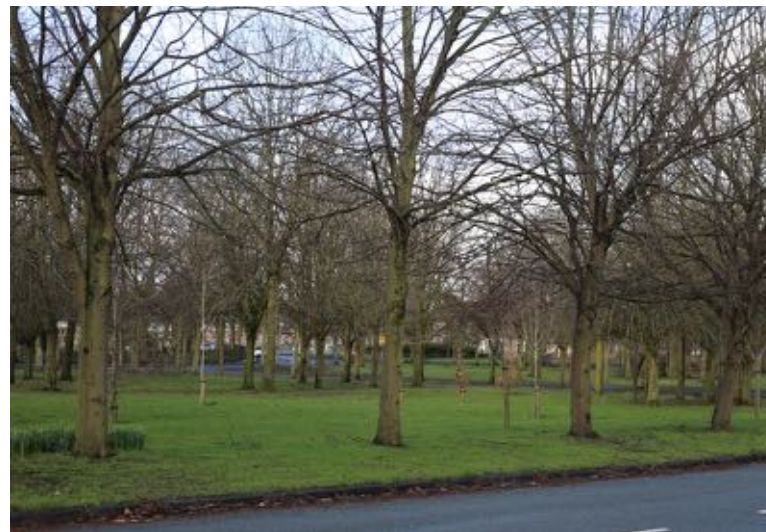
Corniche Road

Corniche Road: A high density tree planting area, which has been recommend for pruning, crown lifting, canopy reduction or selective removal to open up the space and increase potential use of the space.

- Additional planting or alternative planting within selected appropriate areas for habitat creation;
- Additional bulb planting; or
- Wildflower meadow or annual display mix.

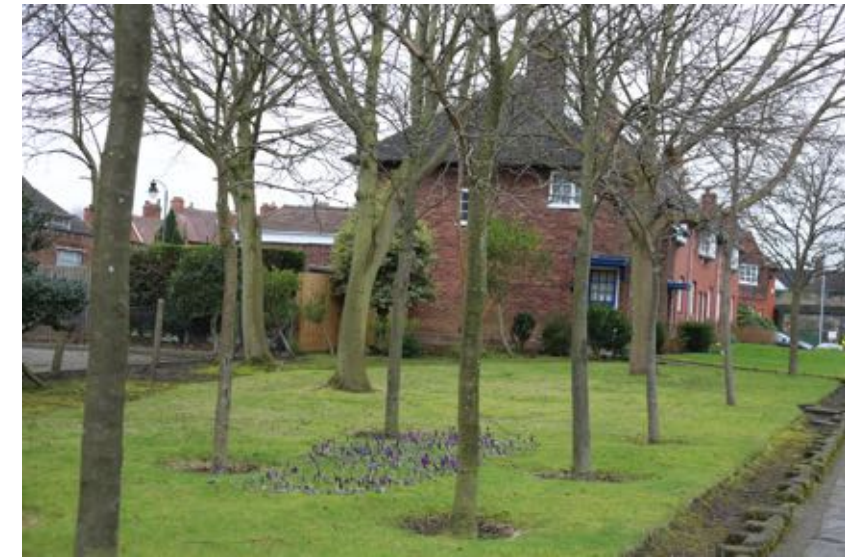
2 Character Area 6: North Village Housing

Northern Bowling Green: Decommissioned bowling green provides additional green space for residents and visitors. This space has a high biodiversity and sustainability potential through the creation of a pocket park along the village's northern edge.

Potential interventions to increase biodiversity and sustainability are:

- Additional bulb planting;
- Long grass;
- Wildflower meadow; or
- Additional infill planting to form more diverse habitat.

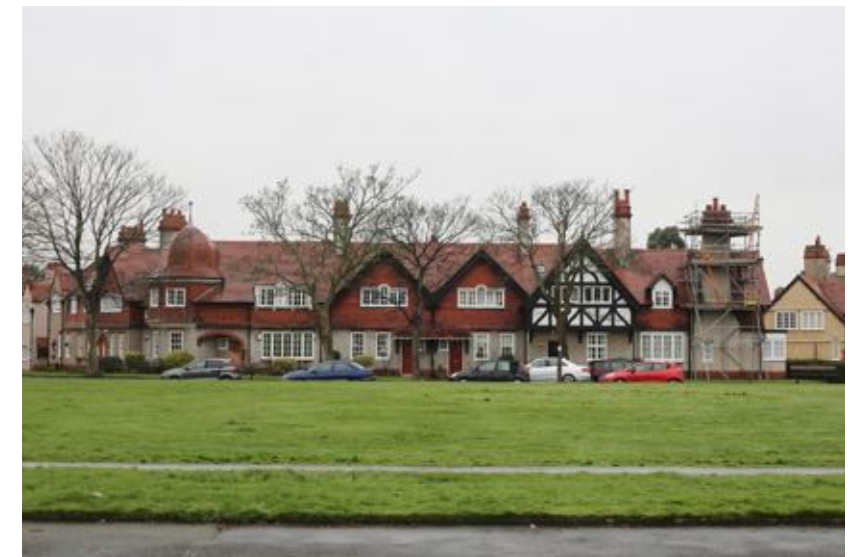
4 Chracter Area 9: The Civic Cross (The Diamond and the Causeway)

The Causeway: An open grass space with nearly mature trees, with limited public access or usability. Could provide small scale biodiveristy opportunities which add interest.

Potential interventions to increase biodiversity and sustainability are:

- Additional bulb planting;
- Removal of bedding planting;
- Long grass to central area with mown edge strip; and
- Wildflower meadow or annual wildflower displays.

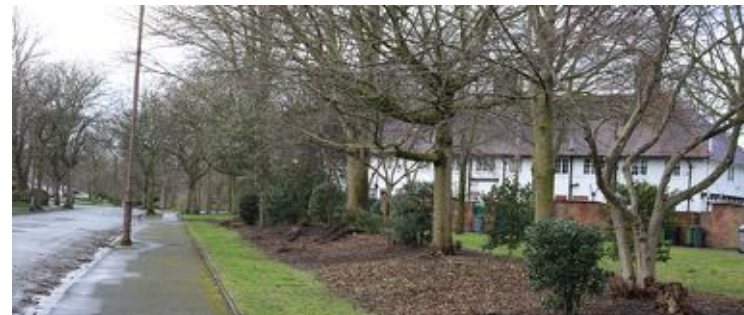
Warf Street/ Water Street

Warf Street/ Water Street: Potential for further development of this space as green corridor within the village, using existing trees, shrubs and ground cover.
Potential interventions to increase biodiversity and sustainability are:

- alteration of management regimes e.g. reduction in pruning;
- long grass;
- wildflower meadow; and
- additional habitat encouraging planting.

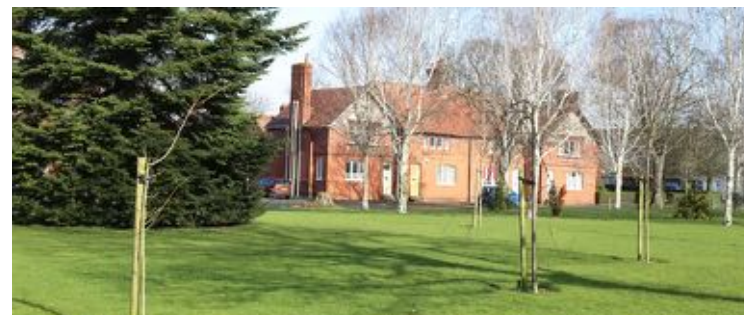
Lower Lane/ Corniche Road

Lower Lane/ Corniche Road: An open space with significant tree planting at various stages, this could become a key biodiversity area through the various tree species in the form of a village arboretum.

Potential interventions to increase biodiversity and sustainability are:

- Additional tree planting of exotic varieties;
- long grass and wildflower planting - reducing mowing maintenance activities.

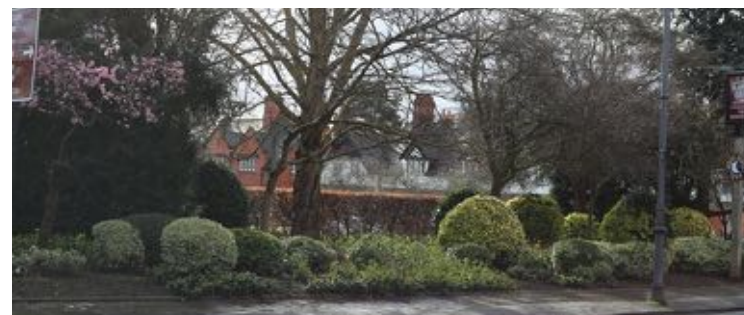
Bolton Road

Bolton Road: Amenity planting verge with high maintenance demands, as a key access corridor through the village. These verges can continue to provide amenity value as well as biodiversity and sustainability opportunities.

Potential interventions to increase biodiversity and sustainability are:

- Infill and simplification of planting and a reduction in maintenance of some species to encourage wildlife habitat.
